DAILY REPORT NO: 010

Site Visit: February 3, 2012 (9:30am to 12:30pm)

Survey Areas: Units 12F, 11F, 10F, 9F, 8F, 7F, 6F, 5F, 4F, 3F, 1F, front entrance, and building exterior. I was unable to gain access to 2F because the floor was in the process of being sanded.

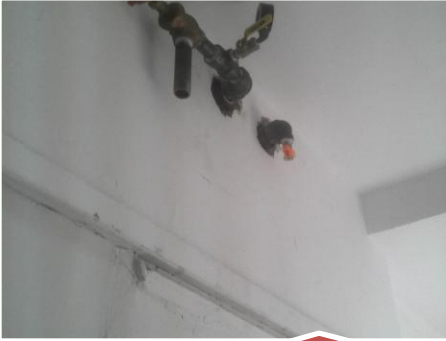
Performance Level: Sprinkler head (trash chute) unit 12F

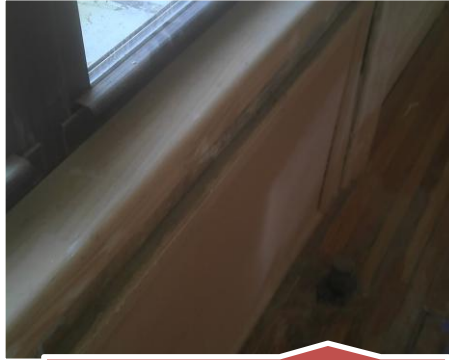
Performance level: Window trim unit 12F

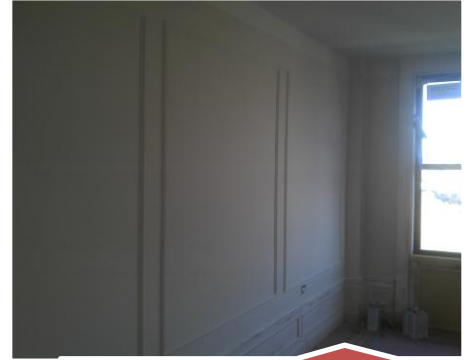
Performance Level: Picture molding

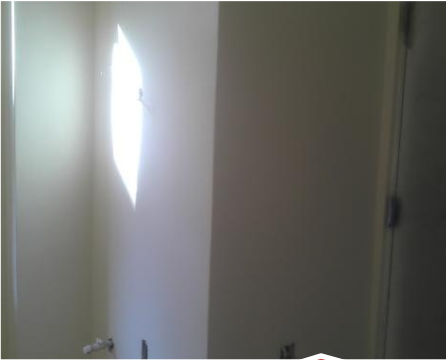
Performance Level: Boxed in trash chute unit 11F

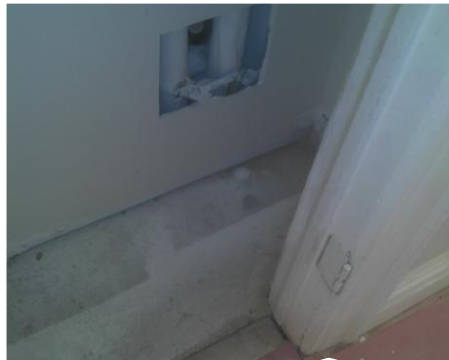
Performance Level: Water cut off valve (hall closet) access.

Access panels: I believe it is imperative to install access panels where the water cut off valve is located. Some units currently have spaces cut out for panels and some do not. Vernon (Dellwood) informed me that all units would include panels.

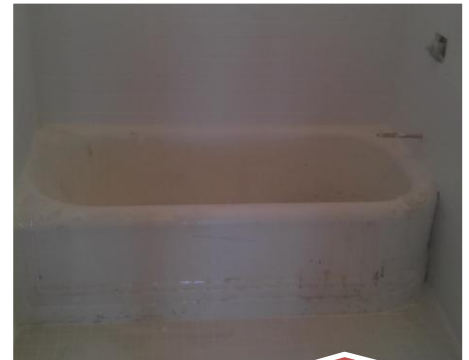
Performance Level: Bathroom unit 9F

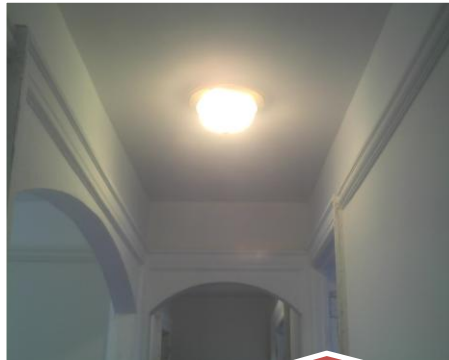
Performance Level: Ceiling frame and finish unit 9F

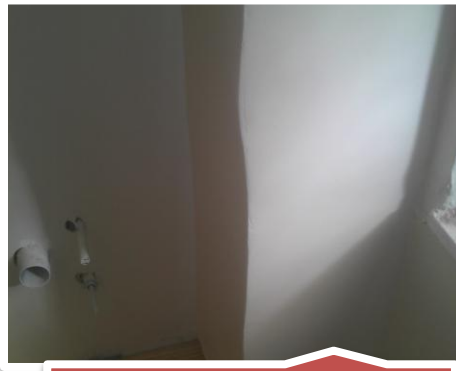
Inadequacies: Uneven framing in kitchen 11F

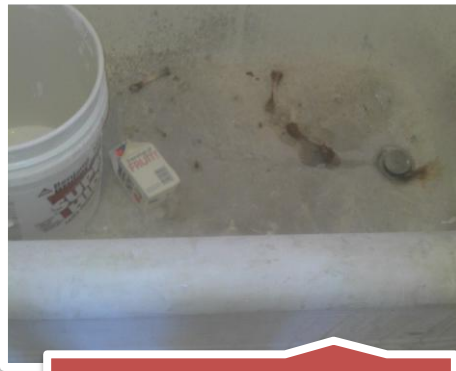
Refuse from workers: Remnants of food were found on the floor and in the bathtub of unit 11F and 10F. Units should be cleaned of this type of debris daily so that it will not attract vermin.

Inadequacies: Bones found littered in the tub 9f

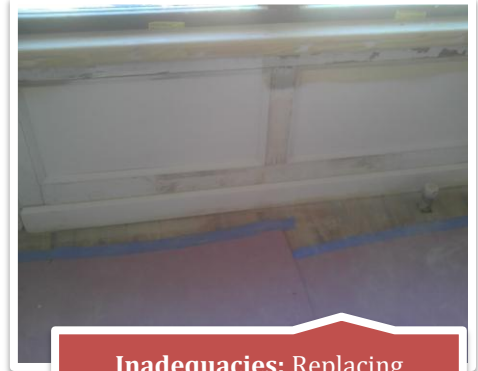
Inadequacies: Replacing damaged wall panel behind former radiators.
