**DAILY REPORT NO: 011**

Site Visit: February 16, 2012 (1:30am to 3:15pm)

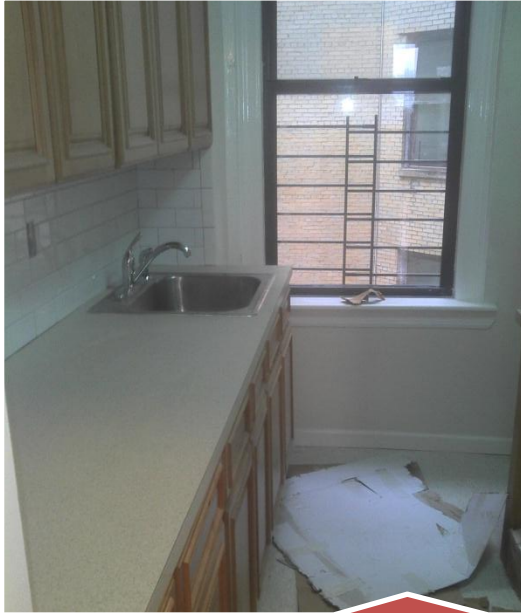
**Performance Level:** New kitchen cabinets, countertop, and sink - unit 12F

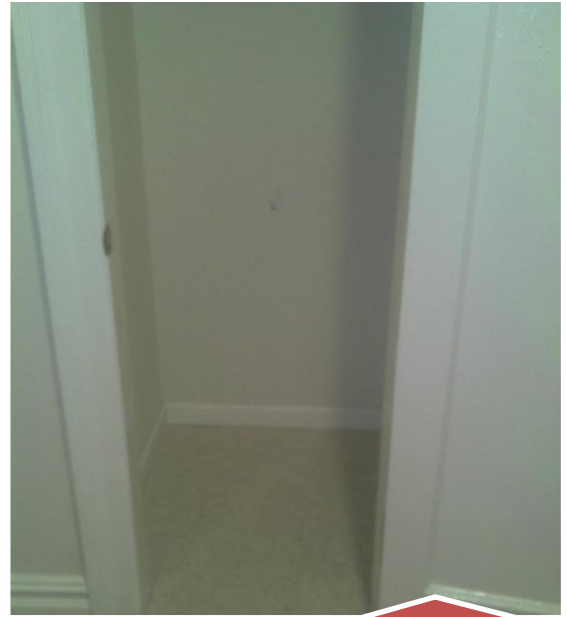
**Performance level:** Completed (former maids room) closet - unit 12F

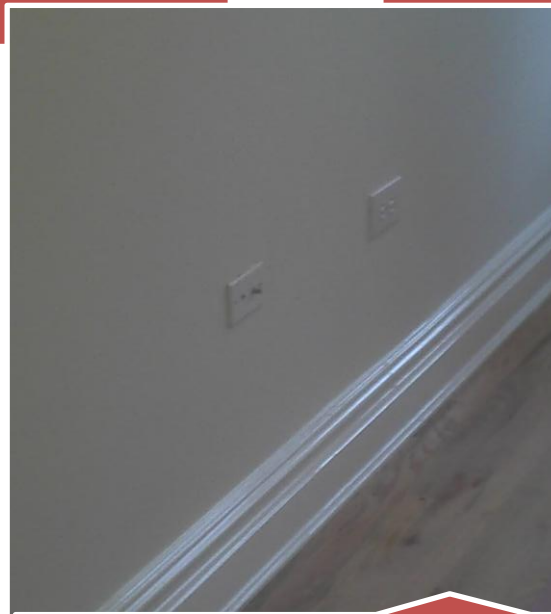
**Performance Level:** Finished outlet covers and wood floor base - unit 11F

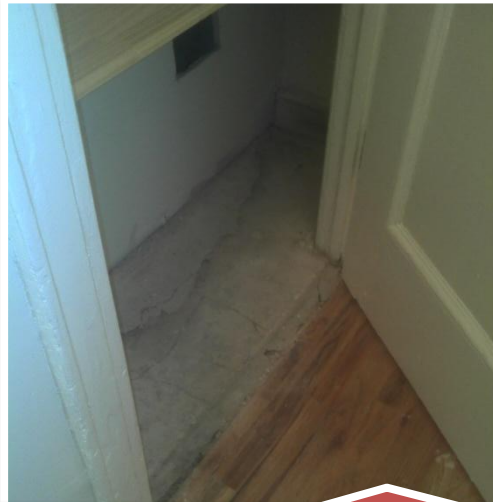
**Access panels:** Access panels for the water cutoff (hallway closet) were not yet installed. These should be installed prior to the punch list.

**Hallway closet floor:** In some of the hallway closets vinyl tile has not been installed. This must be installed prior to punch list.

**Inadequacies:** Hallway closet with no access panel or vinyl tile - unit 8F

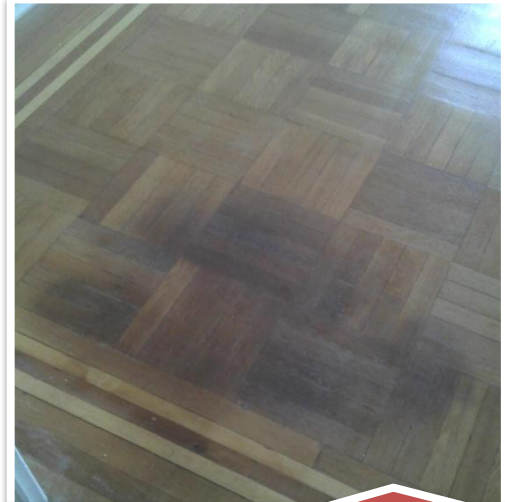
**Inadequacies:** Stained floor - unit 11f
