DAILY REPORT NO: 012

Site Visit: May 18, 2012 (9:15am to 11:30am)

Survey Areas: Units 12F, 12C, roof, trash chute area, hall ways.

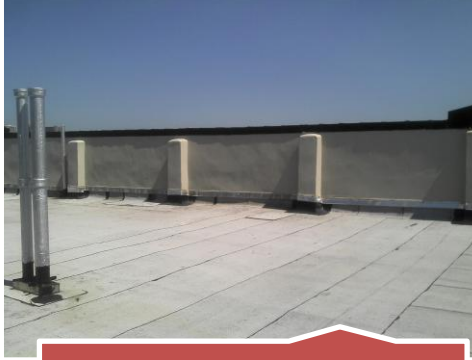
Roof Repair: It appears that the vast majority of work was conducted on the interior portion of the parapet walls. This work appears to include the following:

Performance Level: Roof and parapet wall

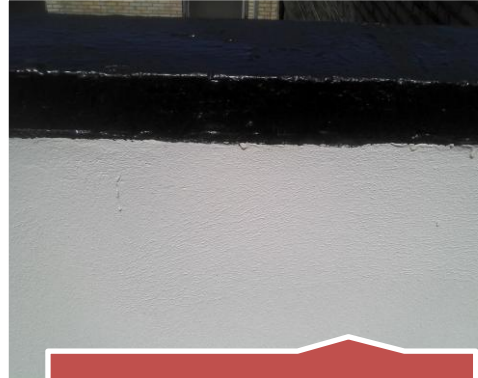
- Waterproofing of parapet walls including interior surfaces facing inward toward the roof.
- Counter flashing repaired or applied on the interior surface about 5" to 7" above the roof membrane.
- At least one waterproof membrane applied over the coping, at least one waterproofing membrane applied and extending down the interior surface from the coping to the roofs surface cap.

Performance level: Waterproofing applied to coping and interior parapet wall.

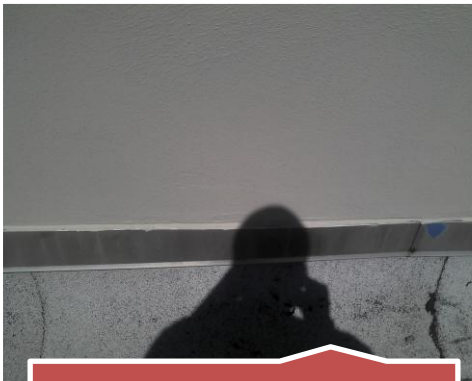
Performance Level: Counter flashing above roof surface cap.

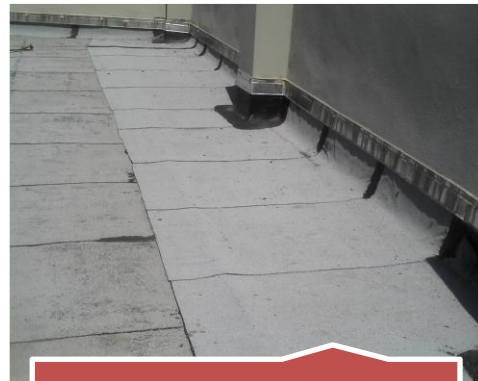
The work is quite extensive and has been conducted on all parapet surfaces. In addition, at the time of my inspection, all areas where the underlying roof membrane was exposed the surface cap has been replaced or repaired.

Performance Level: Repaired surface cap.

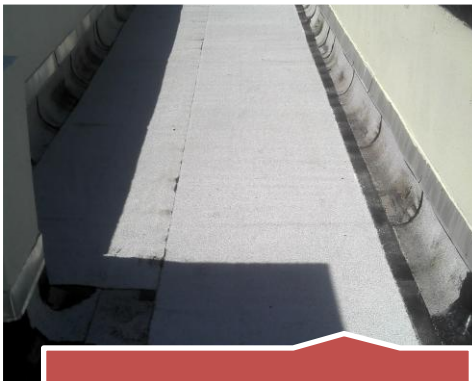
Performance Level: Repaired surface cap.

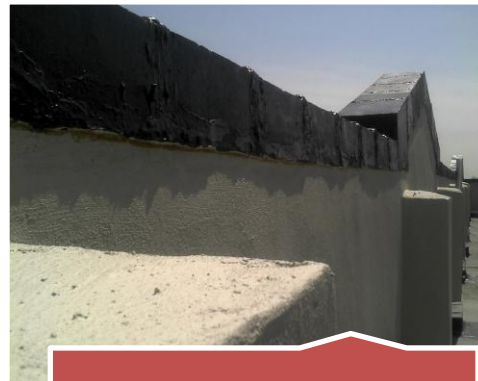
Based upon my experience the applications were conducted correctly, however I would like to know what water proofing products were used and how many applications were applied.

Performance Level: Properly sealed coping and parapet

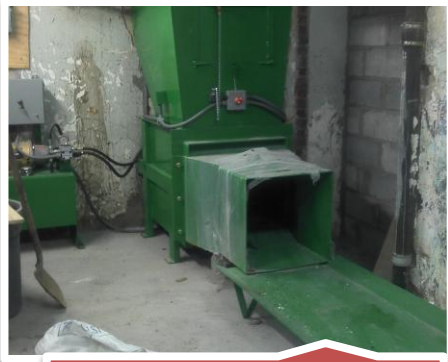
It is my opinion; based upon the size of the building; the compactor and corresponding refuse room are inadequate to remove waste efficiently. The size of the compactor installed and the room it occupies translates to constant monitoring, storing and staging of waste. This work must be done frequently or the chute and staging areas will “back-up” creating an unpleasant smell and attract vermin.

Inadequacies: Small chute and compactor room.

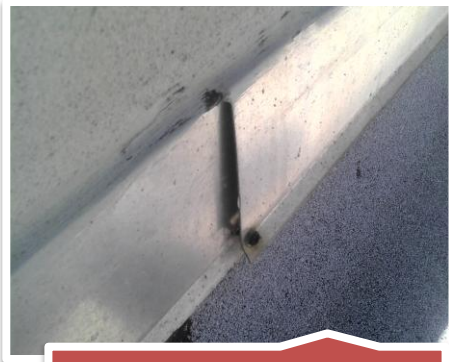
Roof Repair: There are a few areas that need tar application to close joints in the counter flashing. In consideration of the recent water proofing work, it is my opinion that this work should have been conducted initially while the built up roof was being installed.

Inadequacies: Exposed counter flashing joint.

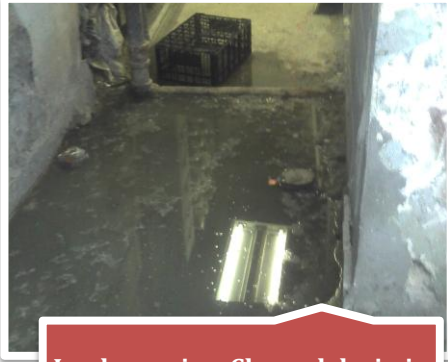
A significant amount of water has accumulated above a clogged drain. This needs to be remedied before the chute and compactor become operable.

Inadequacies: Clogged drain in trash chute room.

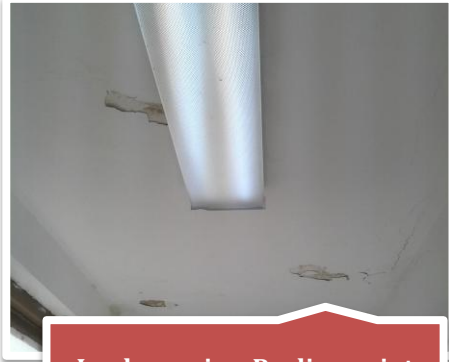
Residential Units on the 12th floor (12F and 12C): Both residents experienced water leakage from the roof into their apartments. These leaks were conspicuous by the water marks left on the ceiling. In both cases the residents conveyed that water leakage had ceased.

Inadequacies: Peeling paint from previous water leakage.
