DAILY REPORT NO: 013

Site Visit: June 29, 2012 (9:30am to 11:15am)

The purpose of this visit was to survey the G line units in relation to how the utility lines, which need to be replaced, affect the E line units. In addition I was able to have a discussion with the contractor and Barbara Malpica (SHUHAB) about the appropriate and necessary steps to take to conduct work with minimizing the length of displacement of residents.

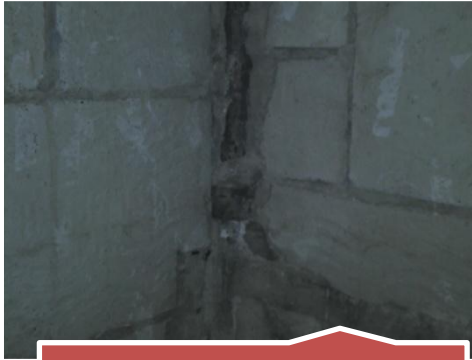
Unit 7G1: The waste line in question shared with the E line only affects the rear most bathroom in this unit. Upon demolition of the kitchen and bathrooms the intricate networks of plumbing lines have been exposed. They illustrate lines replaced and tied to older lines most likely based upon breaks manifesting leaks. The line carrying waste from the kitchen appears to be inadequate in size based upon current building code.

Inadequacies: Exposed waste line unit 7G bathroom. Shared line with E line unit.

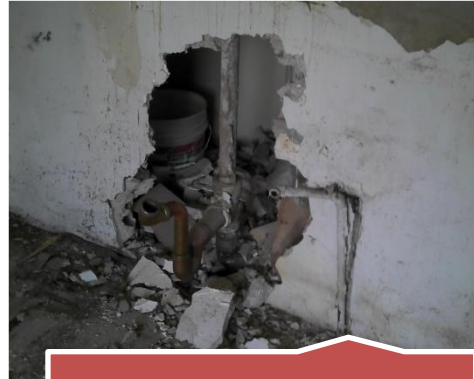
Inadequacies: Kitchen waste line. Smaller than what is required by code. this line should be replaced

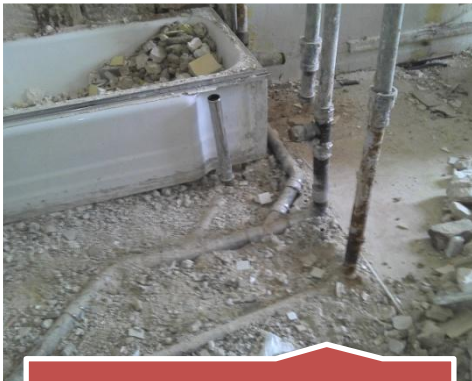
Inadequacies: Severely limited capacity waste line from kitchen

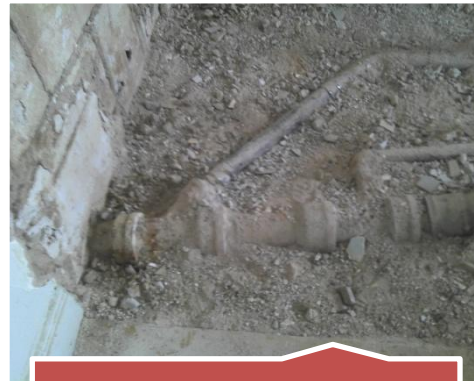
Inadequacies: Waste line ties to main line.

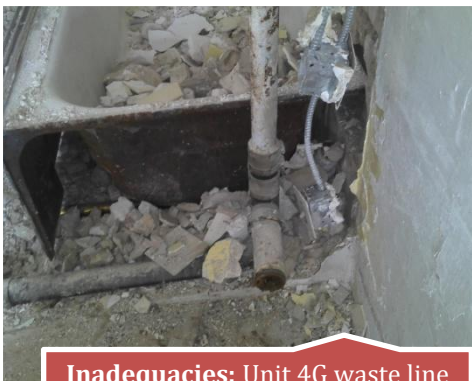
Unit 4G and Unit 4G1: The pipes in these units illustrate similar issues as noted in unit 7G1. Demolition in 4G's bathroom illustrates the adjoining E waste line and E unit exposed piping to the tub and sink.

Inadequacies: Unit 4G waste line connection from kitchen and bathroom tub. Size of line is inadequate.

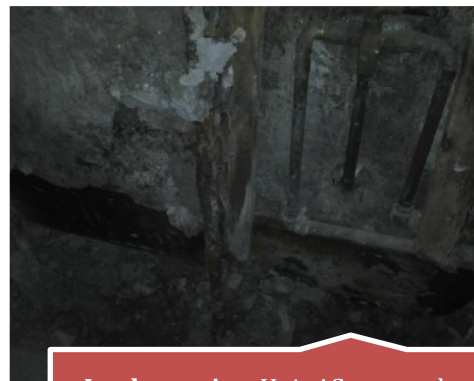
Inadequacies: Unit 4G exposed waste line, shared with E line. Exposed bathroom plumbing E line.

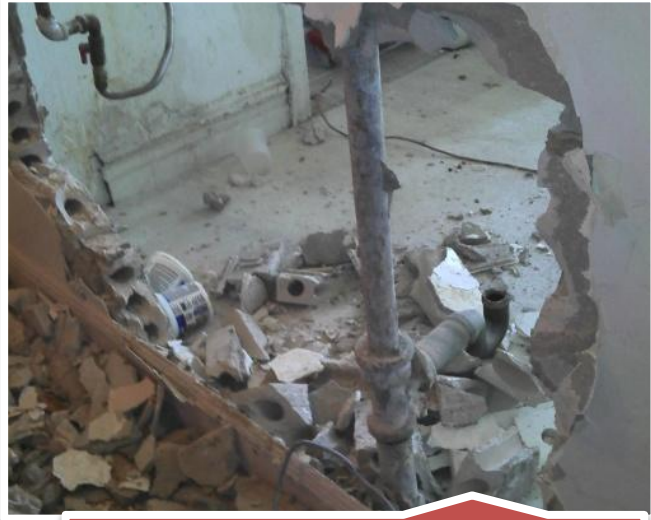
Inadequacies: Unit G41, kitchen waste pipe.
Smaller than code requirement.

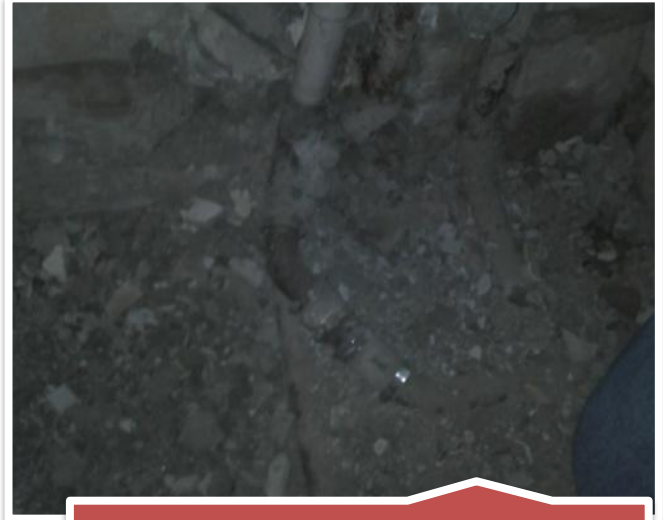
Inadequacies: Waste line tie.
