DAILY REPORT NO: 014

Site Visit: Thursday, July 19, 2012 (10:20am to 12:15pm)

Survey Areas: Units 12G&G1, 11G&G1, 10G&G1, 9G&G1, 8G&G1, 7G&G1, 6G, 5G&G1, 4G1, 3G&G1, 2, 1G1, Basement.

The purpose of this visit was to survey the G line units in conjunction with HPD representatives to assess replacement of the G line plumbing and waste lines. In addition I was able to have a more detailed discussion with the general contractor about their proposal to remedy the shared waste line affecting the G and E line units.

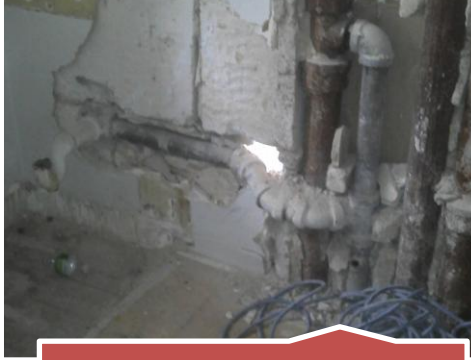
Inadequacies: Exposed waste line unit 12G bathroom..

The scope of work expresses that the waste line pipes should be changed at approximately 20%. This is insufficient and detrimental to the building. Based upon my observation, estimated age of the pipes, pipe material and previous partial replacements, a 100% replacement should be applied.

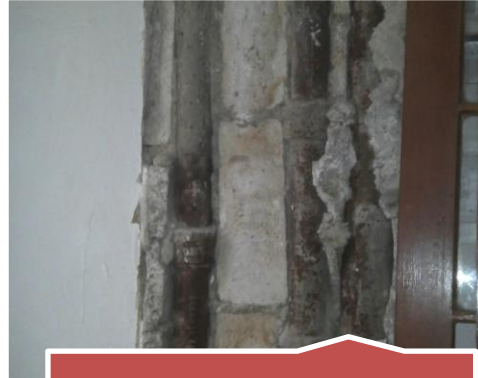
Inadequacies: 12G exposed waste line.

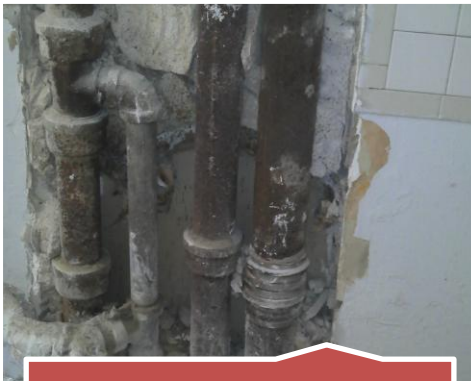
In general the existing waste lines are of galvanized steel material. Based upon the age of the building and the life expectancy of galvanized pipe it is my opinion that the piping needs to be replaced. It appears that the pipes were from the original construction dating back ninety-five (95) years to approximately 1914. Galvanized pipes generally have a life expectancy of fifth (50) years. Therefore the life expectancy of the pipes has been surpassed by approximately forty-eight (48) years. Although the City of New York primarily has soft water over ninety-five years the mineral build up from water and waste will significantly affect any pipe material. Unfortunately, two things general happen to galvanized pipes of this age. One, mineral build-up and two the severe corrosion at the joints. When the pipes are threaded the protective galvanize is cut away, thus exposing bare metal. Over time the joints will corrode and eventually break. Partial replacement of the pipes will undermine the joints thus

Inadequacies: Exposed galvanized waste lines 11G

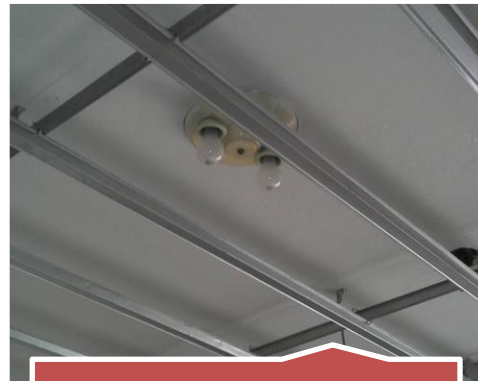
Apparently many residents have adverse feelings regarding the drop of the ceiling height. The argument is one that primarily consists of a loss of aesthetic value. However the contractor’s argument is that the drop provides needed space to run the necessary conduit for the new electrical wiring. This is confirmed by the scope of work illustrated in the drawings.

Inadequacies: Framing for ceiling drop (11G).

Prior to the construction of the E line units a final discussion, between the owner, contractor and residents needs to be conducted so that if the owners proceed with the ceiling “drop” the residents are fully aware of the reasons why.

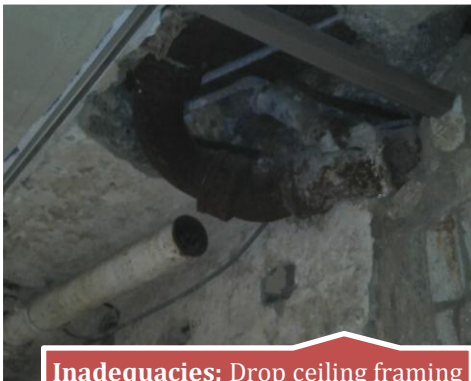
Inadequacies: Drop ceiling framing with exposed waste line and old disconnected line which needs to be removed (7G).

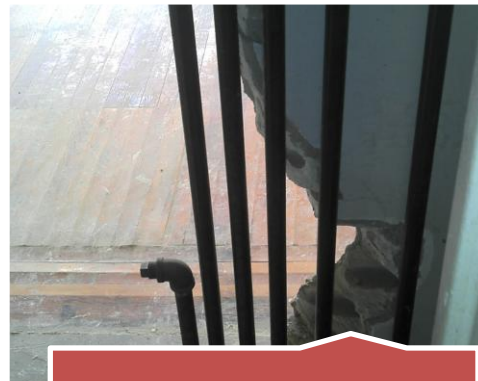
Inadequacies: Unit 6G installed gas lines.

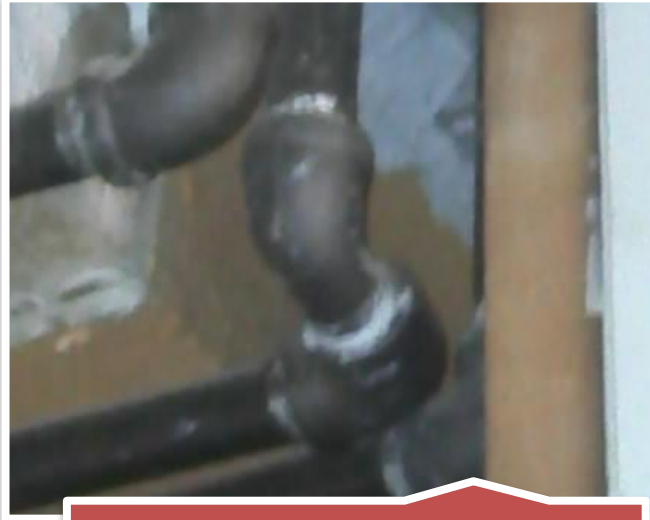
Inadequacies: Incorrectly installed double elbow for gase line.
