DAILY REPORT NO: 015

Site Visit: Friday, September 12, 2012 (10:30am to 12:45pm)

Survey Areas: Units 11G&G1, 10G&G1, 6G, 5G&G1, 4G1, 3G&G1, 2, 1G1, Basement.

The purpose of this visit was to survey the G line units regarding the progress and quality of workmanship of construction.

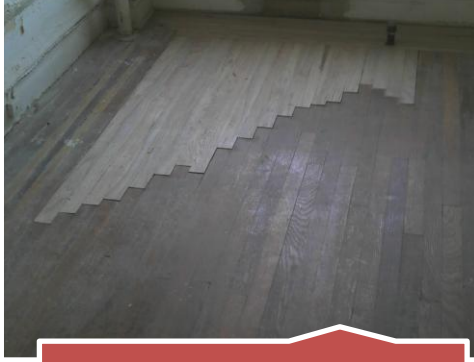
New wood slats have been installed in floor areas where the wood could not be preserved. In some cases where wood was installed to mimic the existing floor; the new wood is not “flush” with the older wood. This will cause a tripping hazard.

Inadequacies: Wood floor trip hazard

Either the wood needs to be sanded or reinstalled to create a flush plain.

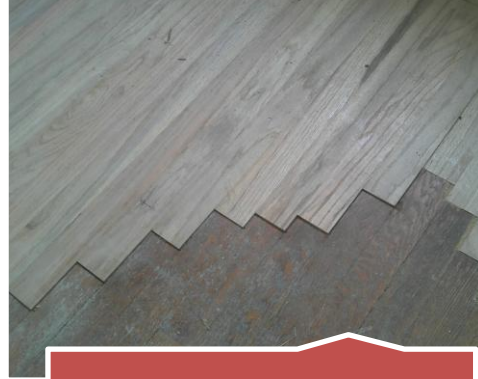
Inadequacies: Wood floor trip hazard

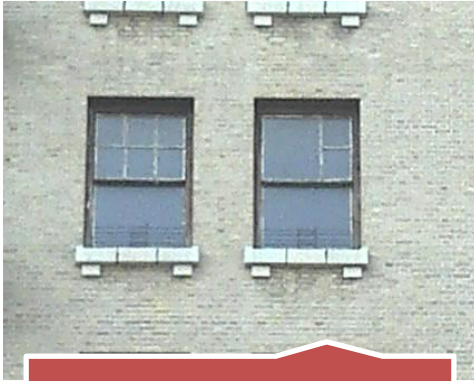
The living room windows for the large G line apartments on the 6th and 10th floors are the older original wood frame windows.

Inadequacies: 6th floor wood frame window

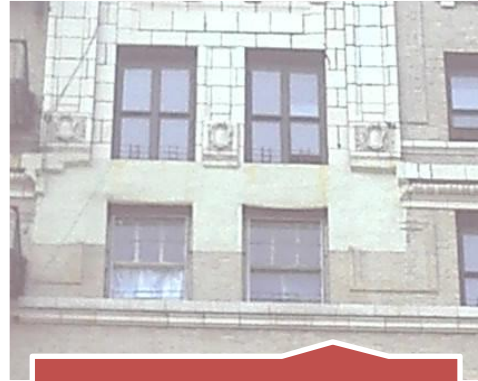
Inadequacies: 10th floor wood frame window

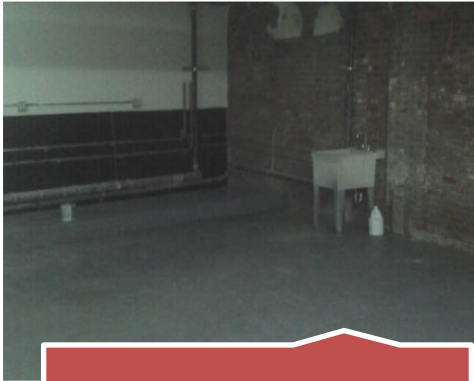
Upon my visit to the property a representative from the company to provide and install washers and dryers was present at the site. According to the representative the plan is to install six (6) washers and six (6) gas powered stackable dryers. In consideration of this plan it is my opinion that the number of washers and dryers is extremely deficient for the total number of units in the building. Based upon general design standards one washer and dryer should be installed for every eight (8) to ten (10) family apartments. In addition the current room is inadequately lighted and the air is stagnant.

Inadequacies: Laundry room inadequate lighting.

- Allow a minimum of 25 square feet per machine.
- Provide a minimum clearance of 8' between floor and overhead pipes
- Locate dryers on exterior building walls. Long ducts increase installation costs and are less effective for proper venting.
- Provide sufficient lighting. Fluorescent lighting provides 2 ½ times the lumens obtained from incandescent lighting (i.e. a 40 watt fluorescent is equal to a 100 watt incandescent). This is extremely important because the laundry room is secluded and there needs to be a high sense of safety.
- Provide adequate ventilation and air flow to alleviate the current and further stagnant air in the room.

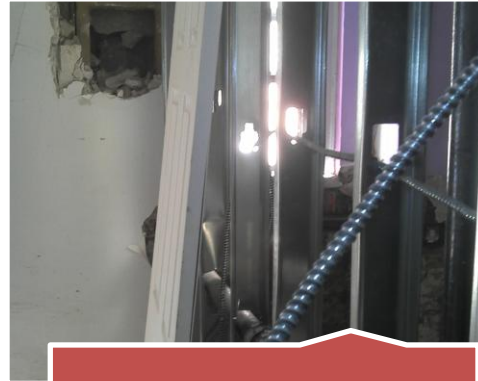
A new wall is being installed between the G & G1 units where the bedroom exists for the one bedroom and the bathroom of the larger three bedroom units.

Inadequacies: Framing for new wall between units.

In consideration of such close proximity and a bathroom, proper insulation should be installed to minimized noise affecting the adjacent apartment.

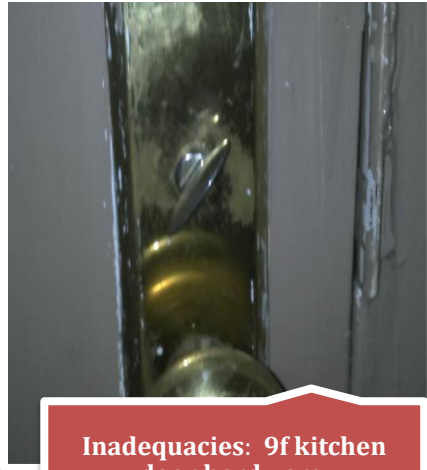
Upon my survey of the unit, per the request of the tenant, it appears the door and hardware of the exterior door located in the kitchen was inadequately installed. The door's "hung" is skewed and the hardware is not properly affixed. In addition a leak is present either behind the bathroom tub spout or within the wall piping.

Inadequacies: 9f kitchen door hardware.

The contractor should appraise these issues as soon as possible. This is an illustration of why the punch list process is so important to ensuring that items are installed correctly and that the contractors work is finalized.

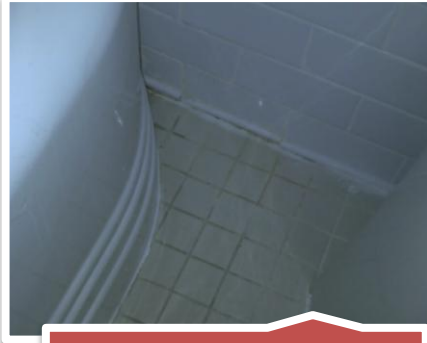
Inadequacies: 9f tub leak.

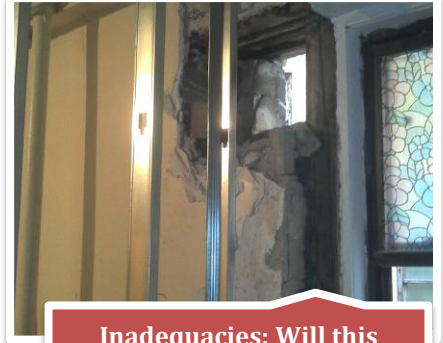
Inadequacies: Will this pocket window be eliminated?
