DAILY REPORT NO: 016

Site Visit: Thursday, November 8, 2012 (10:00am to 2:15pm)

Survey Areas: Units 12G, 12G1, 6G, 5G, 4G, 1G1, 1G, Laundry Room, Basement and 5A

The purpose of this visit was to survey the G line units regarding the progress and quality of workmanship of construction.

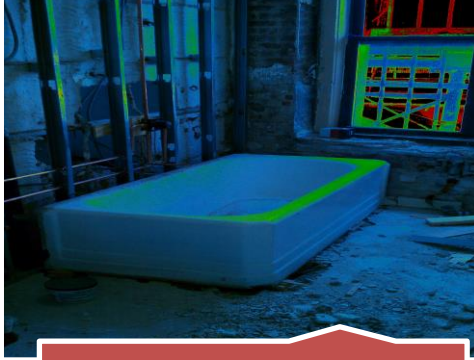
Performance level: Set tub, furred out wall and unfinished floor (4G)

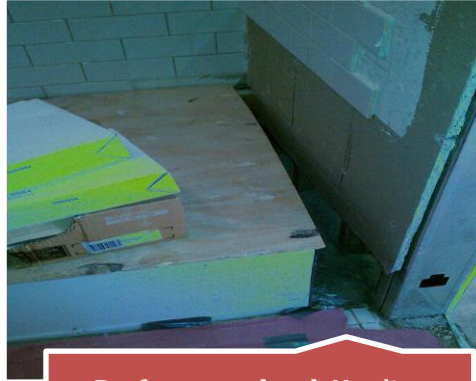
In the G1 one bedroom apartments, new smaller bathtubs have been installed. To complete the finish a tub surround must be installed for a chaise or aesthetic. This framing out should consist of framing, cement backer board and applicable tile. Without a strong framing the top, once weight is applied will become concave and resort in constant repair. This concave affect is already evident in apartment 5A.

Performance level: Needing installation of tub surround between wall and tub.

Closely monitor to assure workmanship.

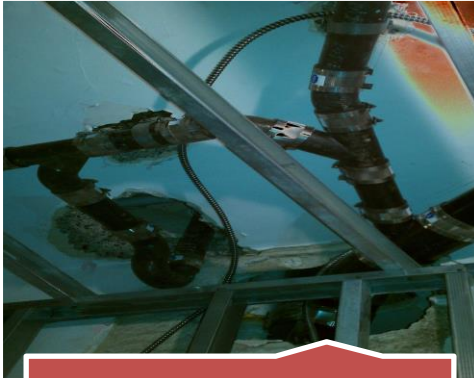
Performance level: Exposed waste lines.

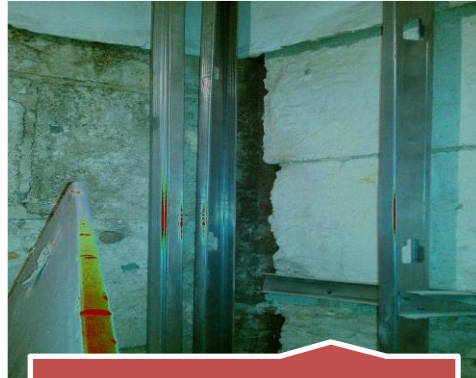
In consideration of building conditions the contractor has had to modify a waste riser and gas risers. It was conveyed to me that the waste riser affecting the rear bathroom in the upper G apartments and E line bathroom, would be cured by running a line adjacent to the existing line and when work moved to the E line the existing line would be replaced by the newly installed line. Upon my survey of the subject riser the line was not installed adjacent to the existing line, but approximately 6'-7' away in an existing hallway closet. I assume there wasn't adequate space to install the pipe adjacent to the existing line thus the contractor thought moving the line to the closet would be more beneficial. However, this will now reduce closet space and create a "furring" out in the closet making it an un-uniform and unbecoming aesthetic.

Inadequacies: G1 rear bathroom, wall furring and imbedded existing waste riser affecting E line.

I acknowledge that changes occur during construction and items must be reformed to meet the internal infrastructure needs of the building. However this is a building in which the end user is present and relocation/planning of newly created risers need some discussion regarding function prior to installation. In the future I would like to know of these issues prior to installation so that we may discuss every alternative and the residents may choose the best compromise.

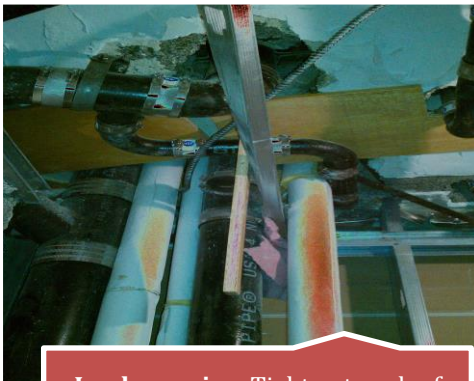
Inadequacies: Tight network of waste lines risers and domestic risers.

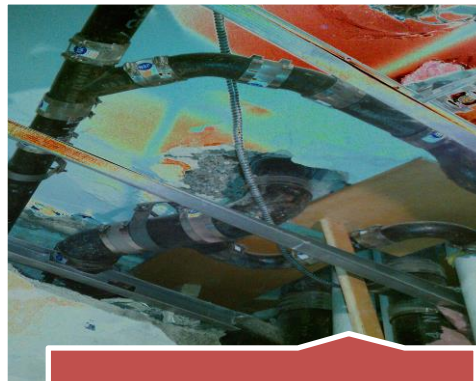
Inadequacies: Tight network of waste line pipes.

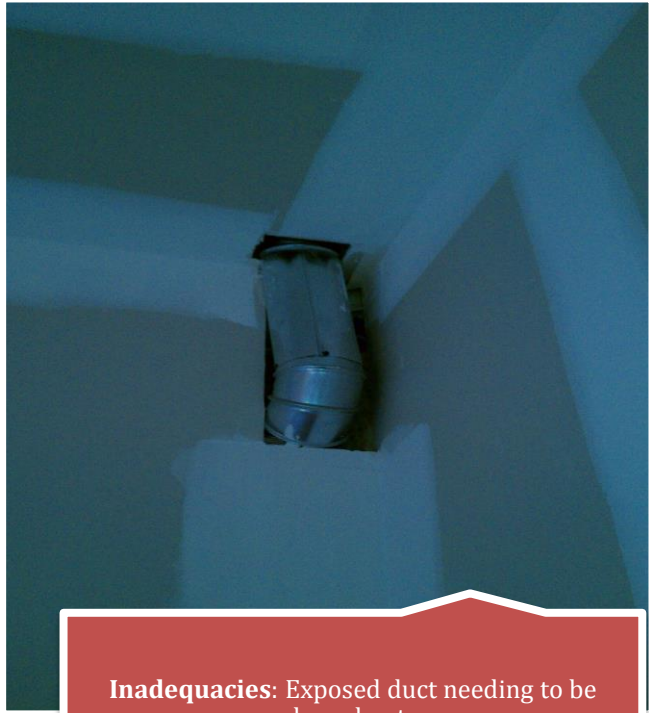
Inadequacies: Exposed duct needing to be boxed out.

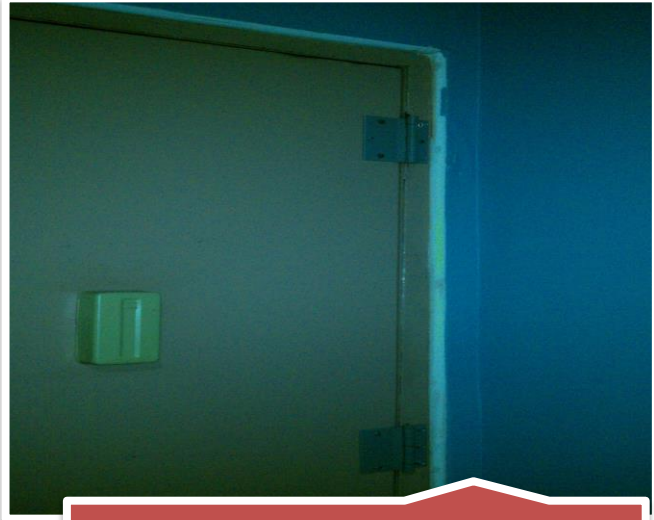
- Main entrance door: The door currently has inadequate hinges, which are not self-closing.
- Third egress door in rear foyer: The installation of the bolt lock does not line up with the door strike plate. Therefore to bolt and secure the door it must be “shimmied” slightly for the bolt to catch inside the strike plate.

Inadequacies: Incorrect door hinges in apartment 5A

Apartment 5A gives credence to the fact that a punch-list upon completion of the units is extremely important. Items such as door hardware and a level floor would have been addressed prior to move-in. Now

unfortunately I believe the one year warranty period has elapsed and now these inadequacies are a part of the living environment. A punch list for the remaining apartments should be implemented.
