# Daily report No.: 002

Survey Areas: Unit 7F, Basement including staging Area, Outside container, Outside scaffolding, Front entrance and posted permits.

Site visit from 13.09.2011 01:00-03:40 o'clock

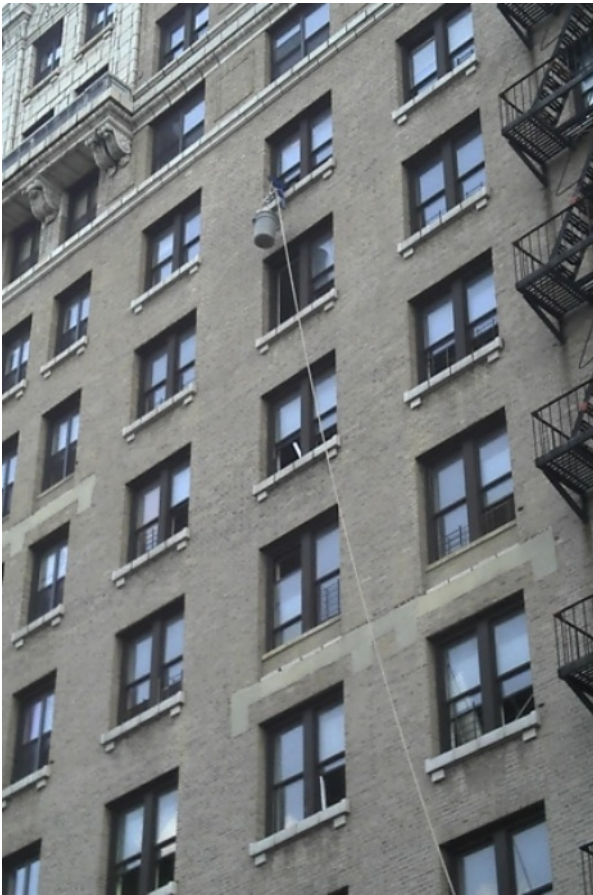
Photo 1 of 4 performance level  
 002.jpg  
 Date: 13.09.2011  
 Bucket with pulley from 7th floor

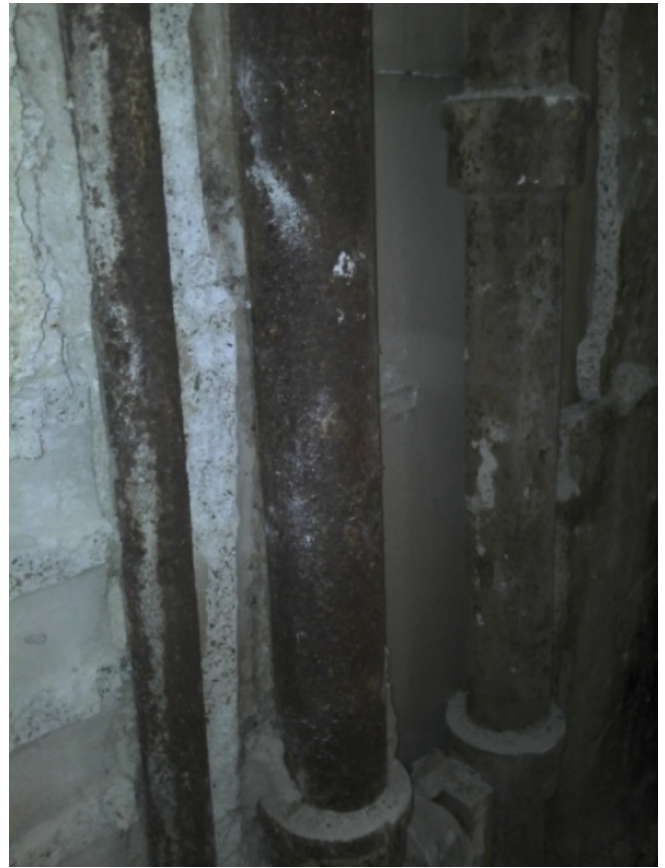
Photo 2 of 4 performance level  
 022.jpg  
 Date: 13.09.2011  
 Waste and water lines

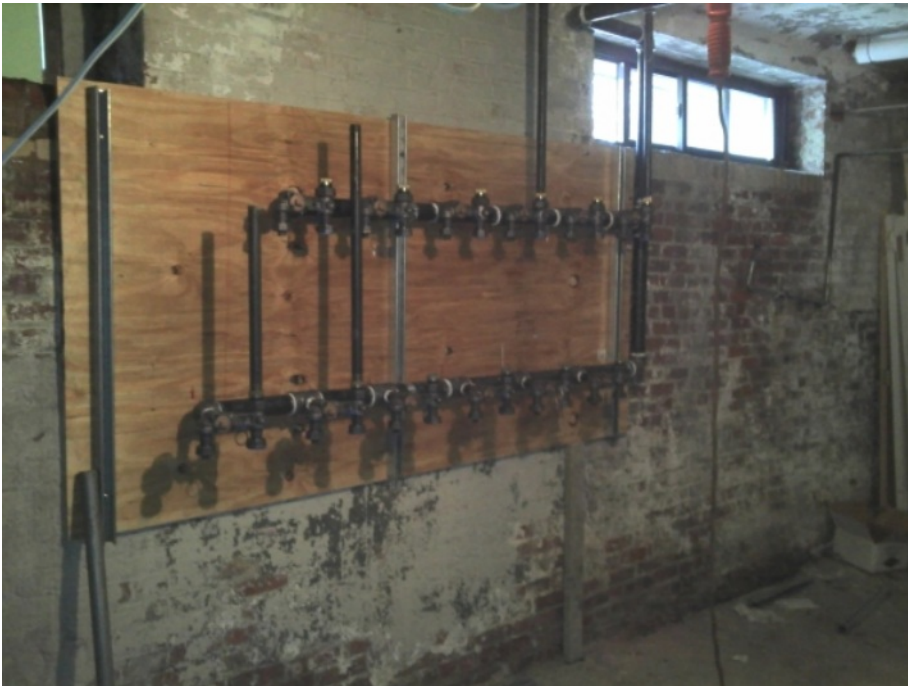
Photo 3 of 4 performance level  
 030.jpg  
 Date: 13.09.2011  
 Gas meter roughing in basement

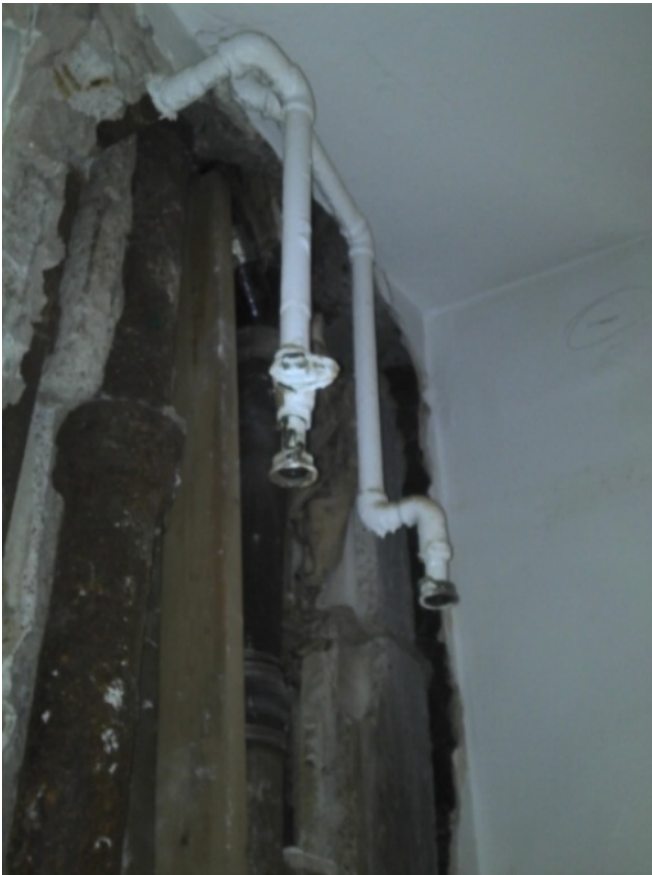
Photo 4 of 4 performance level  
026.jpg  
Date: 13.09.2011  
Waste water and gas lines kitchen 7F

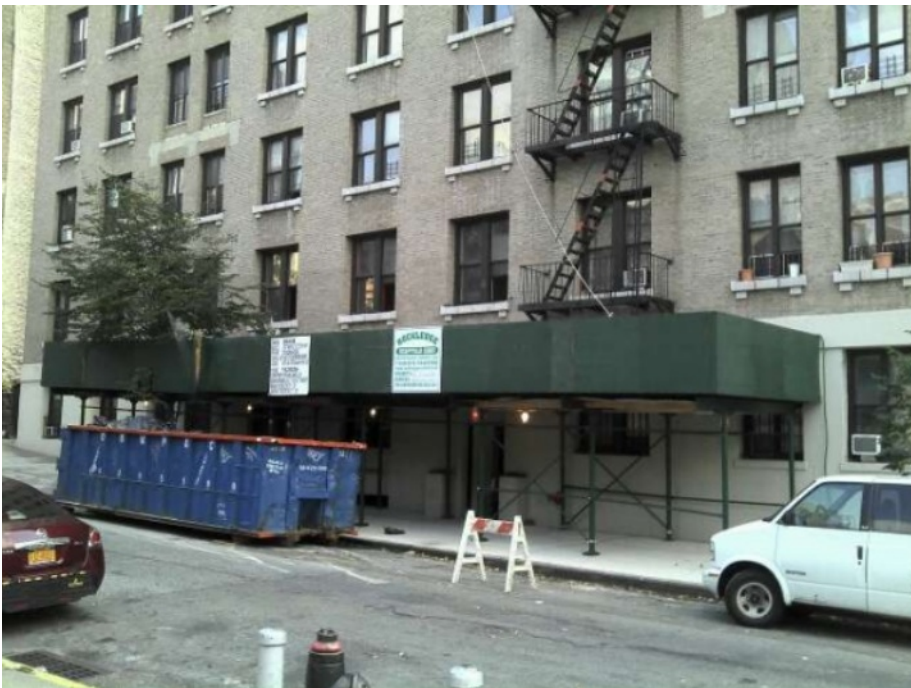
Construction Documents - I requested to see the approved work permit drawings detailing the general construction and electrical. Vernon informed me that the drawings were not on site and we in the process of being revised? I further requested to look at the scaffolding drawings as approved by the DOB. I was told they were not at the site either? The inadequacy exists in not have the proper construction documents on site as required by the building department. If what Vernon was saying is "true", then the general contractor and the property owner would be in violation a penalty rendered with a fine.

Photo 1 of 4 inadequacies  
004.jpg  
Date: 13.09.2011  
Scaffolding - location different from last visit

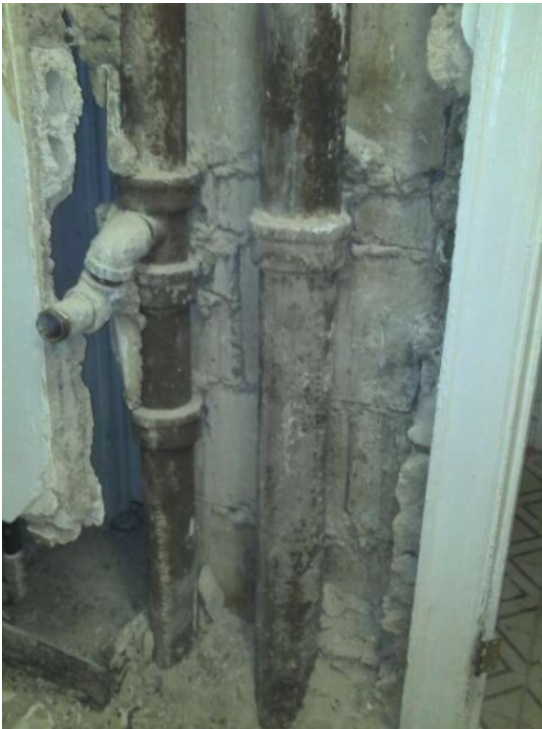
Photo 2 of 4 inadequacies  
 015.jpg  
 Date: 13.09.2011  
 Galvanized piping bathroom 7F (waste line)

**Conclusion:**  
In unit 7F - Based upon a brief view of the F line pipes, the material (Galvanized Steel) and age I would highly recommend 100% replacement. In addition I believe the ceiling can be addressed better aesthetically than the framing currently installed. However once I view the drawings and research other options I will make a recommendation.

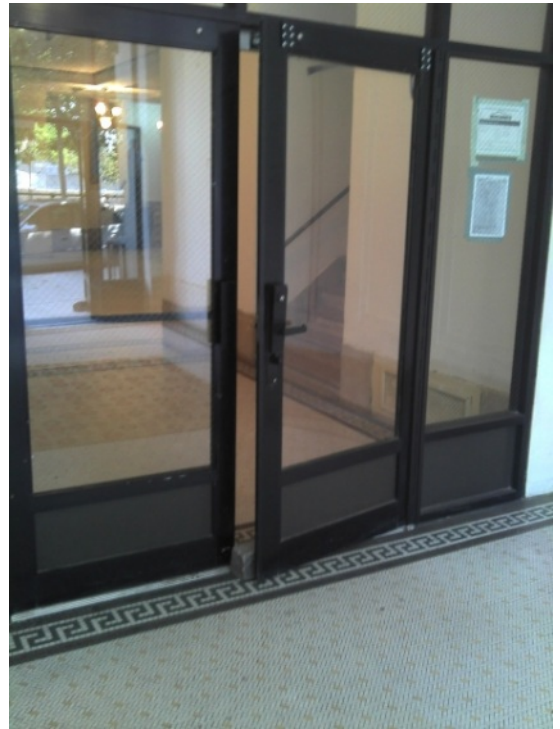
Property Unsecure – (Property Management Issue) - Please note the building continues to be accessible to everyone in the neighborhood, or frankly anyone who wants access. Again a tremendous liability for the owner, general contractor and residents.

Photo 3 of 4 inadequacies  
 012.jpg  
 Date: 13.09.2011  
 Vestibule door ajar

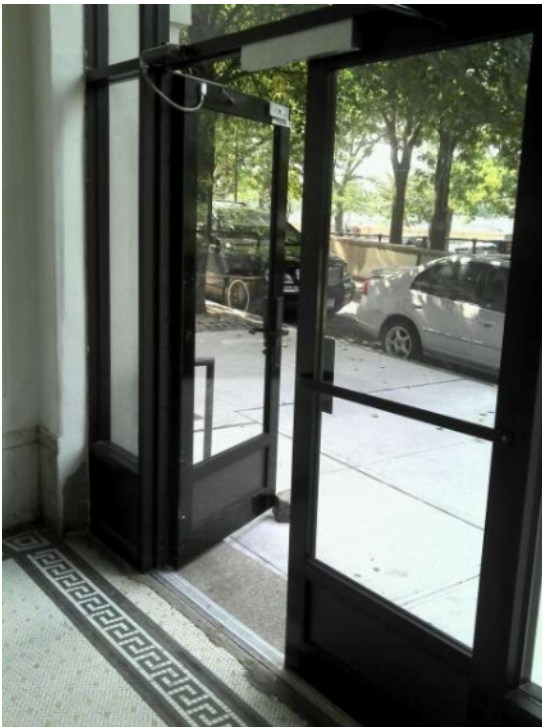
Photo 4 of 4 inadequacies  
 010.jpg  
 Date: 13.09.2011  
 Entrance door ajar
