Daily report No.: 004

Site visit from 05.10.2011 01:00-02:45 o'clock

Survey Areas: Units 12F, 11F, 10F, 1F, the basement, front entrance and building exterior.

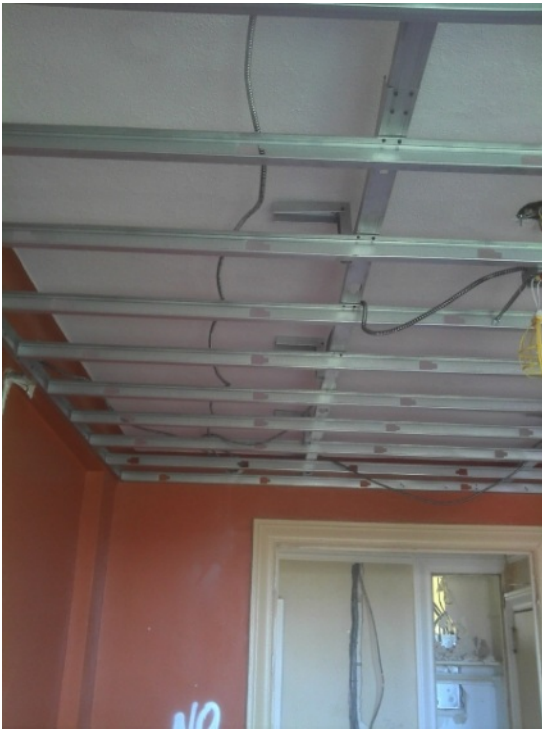
Photo 1 of 12 performance level
004.jpg
Date: 05.10.2011
12F - Living Rm. electrical wiring

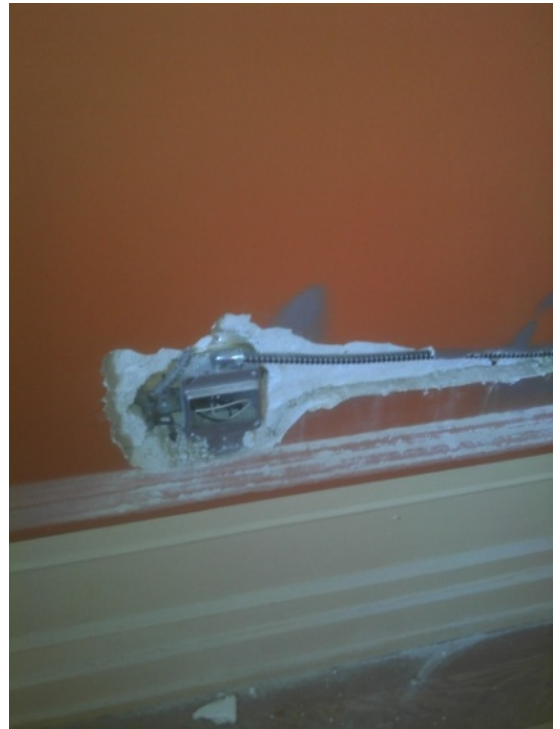
Photo 2 of 12 performance level
005.jpg
Date: 05.10.2011
12F - Living Rm. wall wiring

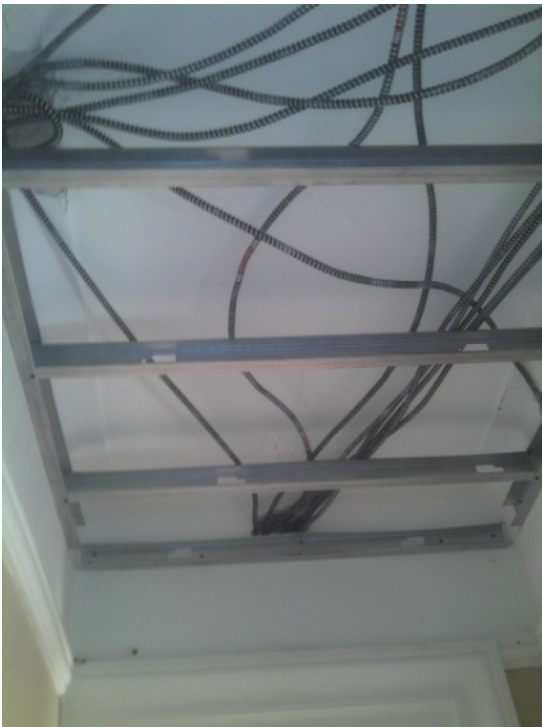
Photo 3 of 12 performance level
007.jpg
Date: 05.10.2011
12F Hallway wiring ceiling

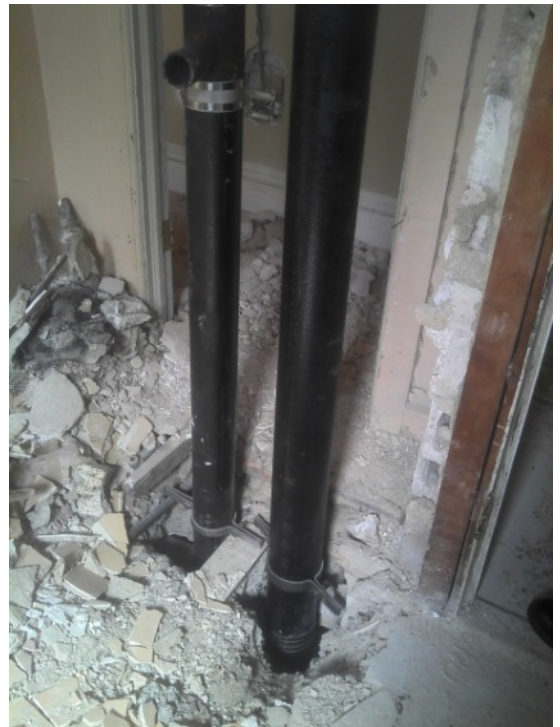
Most of the activity was devoted toward the installation of new galvanized pipe. It appears that the vast majority of piping will be replaced. Pipe was installed in unit 12F and the plumbers were in the process of installing pipe in units 11F and 10F. Unit 10F was undergoing demolition of the flooring, which was earmarked in Mr. Gugich's walk-through notes for total replacement throughout the unit. In addition the ceilings in 10F had previously been framed, dry wall installed and finished. The applicable measure should be taken not to damage the existing finished ceiling.

Photo 4 of 12 performance level
010.jpg
Date: 05.10.2011
12F Bathroom new galvanized pipes

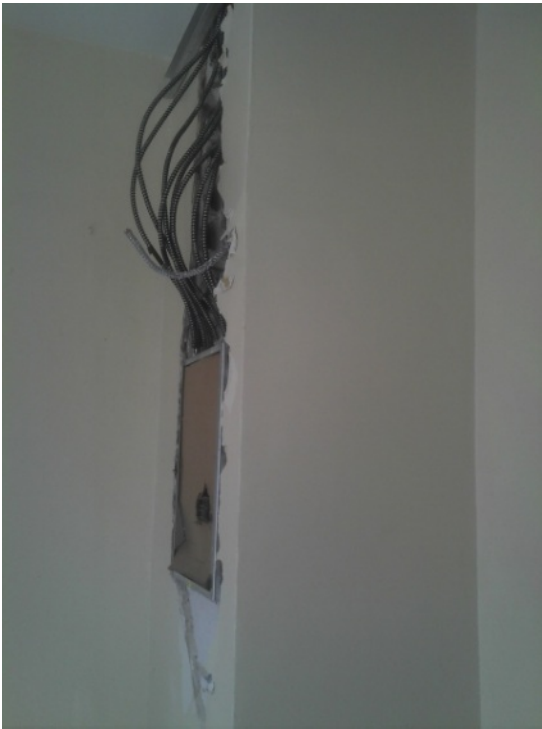
Photo 5 of 12 performance level
 013.jpg
 Date: 05.10.2011
 12F Kitchen electric box

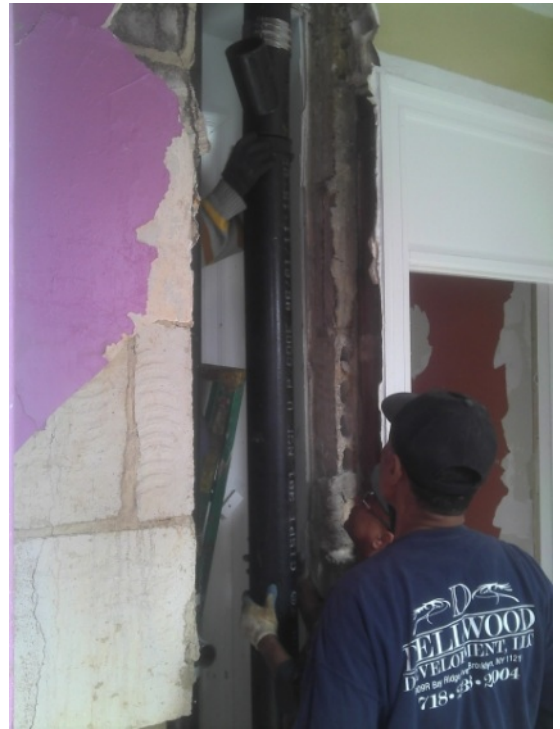
Photo 6 of 12 performance level
 036.jpg
 Date: 05.10.2011
 11F Bathroom installation of new pipes

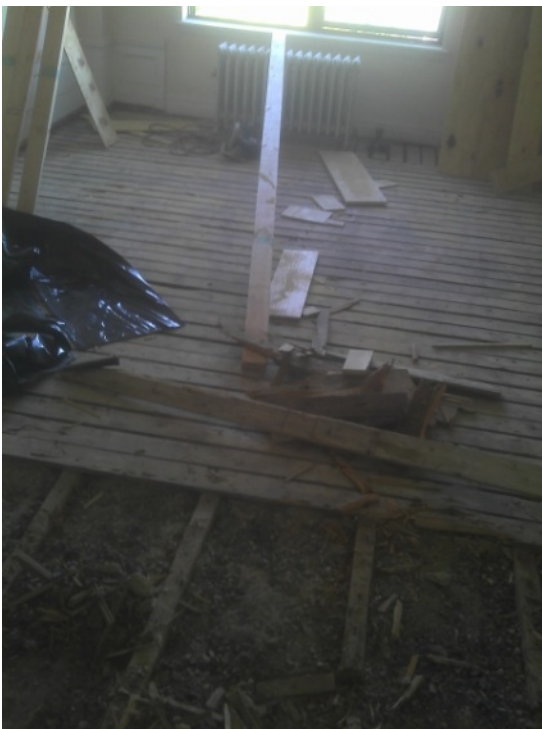
Photo 7 of 12 performance level
 037.jpg
 Date: 05.10.2011
 10F Living Rm. demolition of floor

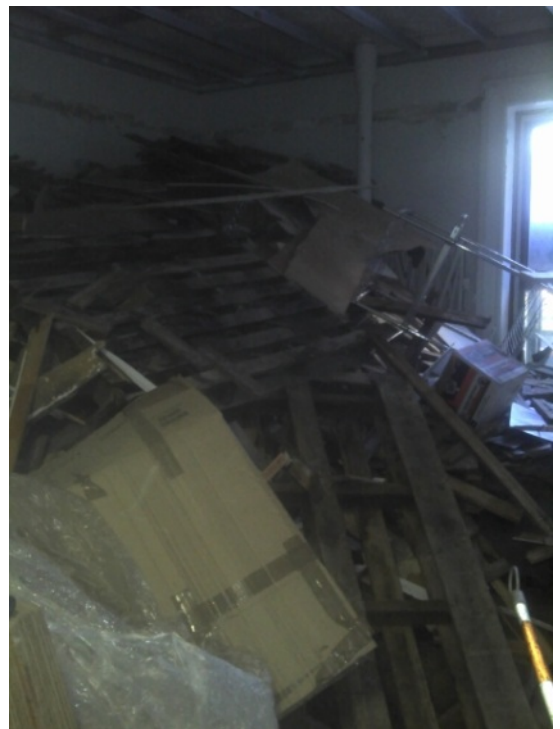
Photo 8 of 12 performance level
 043.jpg
 Date: 05.10.2011
 1F Living Rm. debris staging area

In consideration of debris being moved from the upper units to the first floor, the general contractor is frequenting the elevator. Unfortunately they are not using one designated elevator but both during the day deterring residents from gaining access to their apartments. In addition the type of debris being removed needs to be contained, however remnants of dust are being thrust into the air and it is imperative that the elevator is thoroughly cleaned. The contractor should only use one elevator in deference to the residents. In addition I would recommend that the general contractor employ a debris chute, which must be approved by DOB, to expedite debris removal.

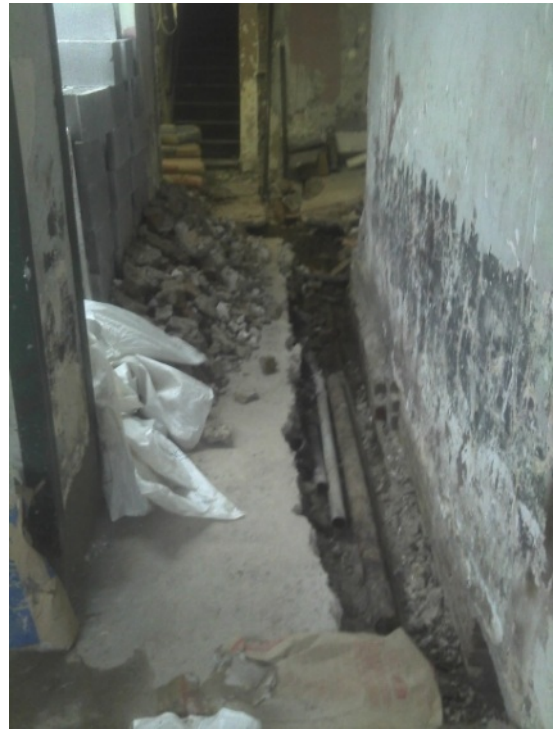
Photo 10 of 12 performance level
 050.jpg
 Date: 05.10.2011
 Basement - trenching for new pipes

A portion of the basement floor has been trenched for installation of a drain line. A cinder block wall enclosure is also being installed and is approximately 80% complete. It appears the area will encompass utility meters. Considering the floor has been trenched the appropriate safety measures should be taken to cordon off this area so as to not incur an accident.

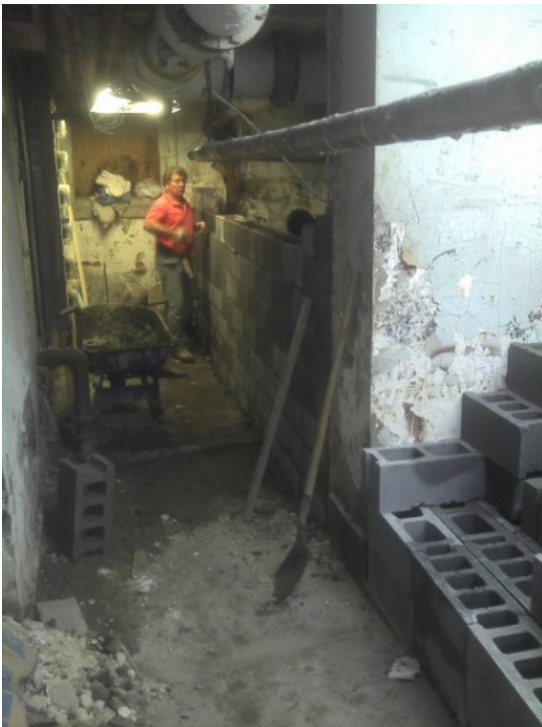
Photo 11 of 12 performance level
 053.jpg
 Date: 05.10.2011
 Basement - erecting new cinder block wall

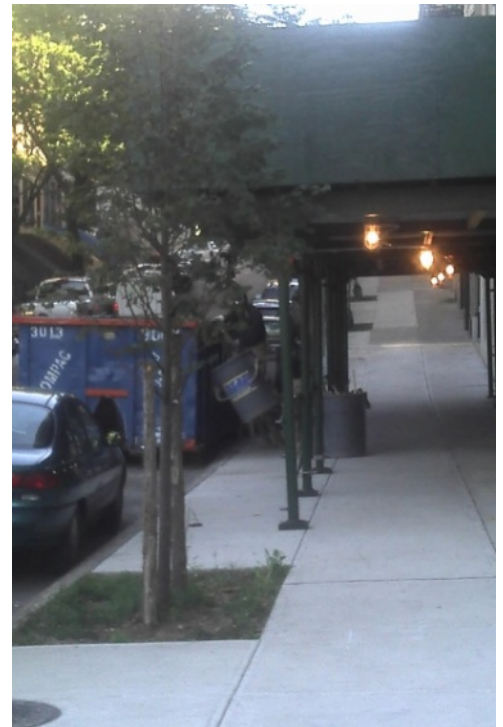
Photo 12 of 12 performance level
 054.jpg
 Date: 05.10.2011
 Hauling debris from 1F to container

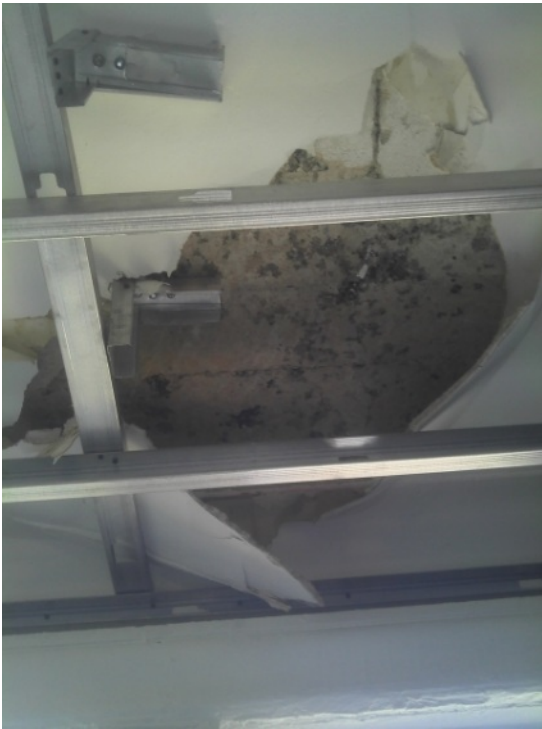
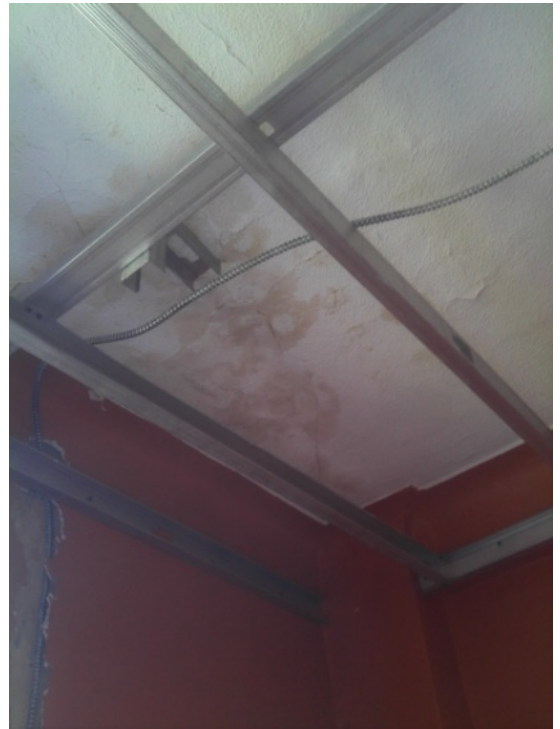
There is a significant amount of water damage that is conspicuous on the 12th floor ceilings and in the hallway around windows. Per my inspection I found the following:

Roof damage – Several areas on the roof illustrated severe breaches in the roofs top membrane. These breaches, in my opinion, were not from customary wear but purposeful or accidental tears. In considering the later there are two possible scenarios that may have led to this damage. One, a rigger hoist has been placed on the roof. If the hoist is not properly moved or is placed on the roof without proper protection it will damage the top membrane of the roof. Secondly, based on the graffiti seen on parapet walls the roof is inadequately secured. This could result in someone making cuts in the top membrane. Both are plausible scenarios pertaining to the roof damage.

Photo 1 of 13 inadequacies
 008.jpg
 Date: 05.10.2011
 12F ceiling water damage liv. Rm.

Photo 2 of 13 inadequacies
 011.jpg
 Date: 05.10.2011
 12F ceiling water damage liv. Rm.

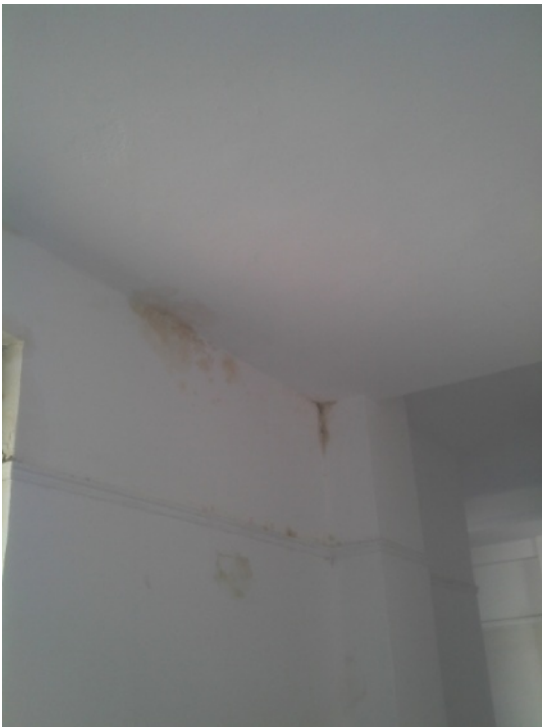
Windows (water damage) – I noticed that tuck pointing and lintel repair around the windows had not taken place in the court yard area. I believe the water that has appeared in the hallway is from breaches in the brick façade.

Photo 3 of 13 inadequacies
 014.jpg
 Date: 05.10.2011
 12th floor hallway water damage

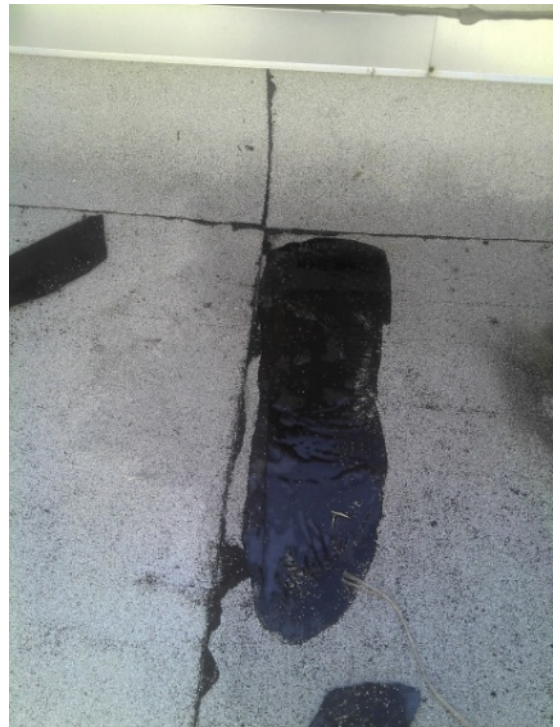
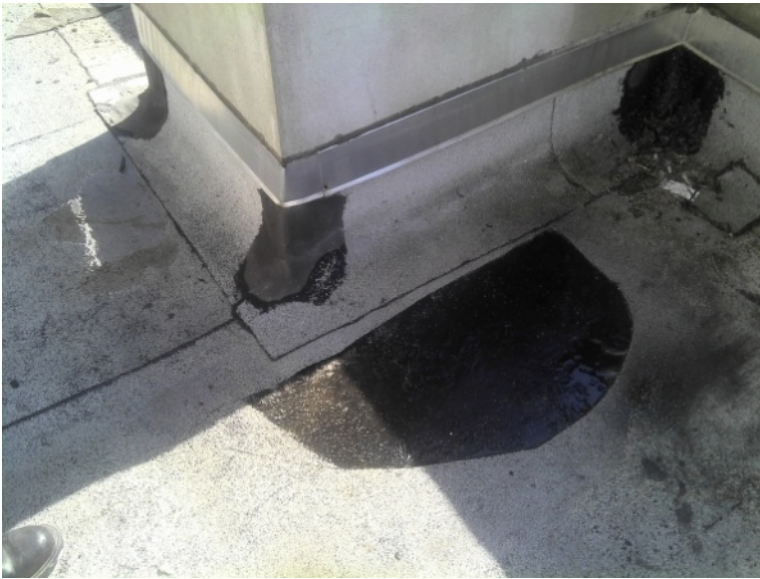
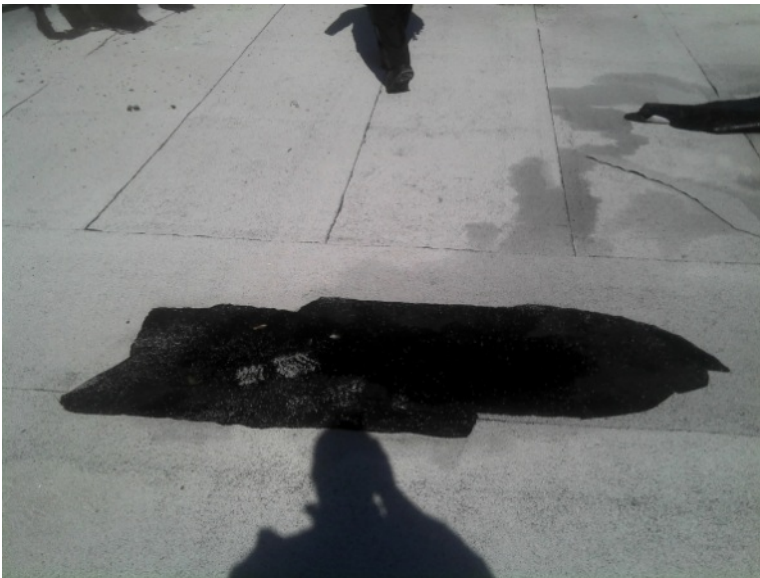
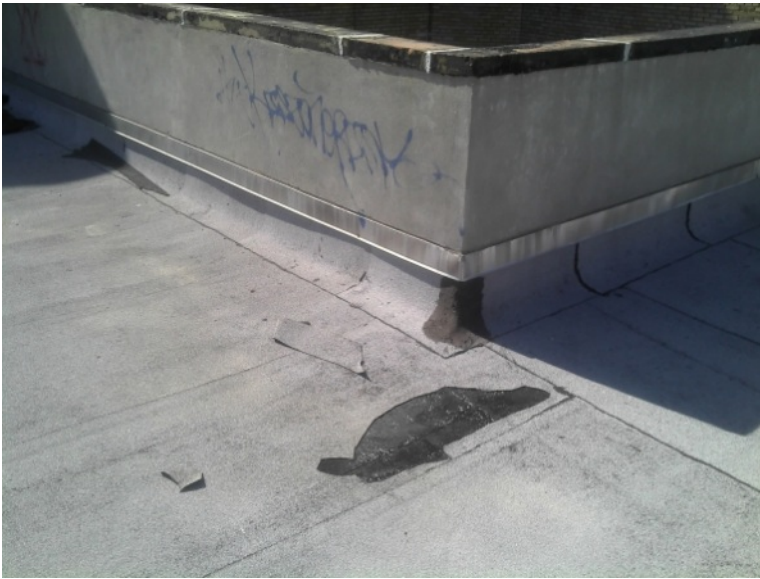
Photo 4 of 13 inadequacies
 022.jpg
 Date: 05.10.2011
 Roof - damage to external membrane

Photo 5 of 13 inadequacies
021.jpg
Date: 05.10.2011
Roof - damage to external membrane

Photo 6 of 13 inadequacies
024.jpg
Date: 05.10.2011
Roof - damage to external membrane

Photo 8 of 13 inadequacies
 029.jpg
 Date: 05.10.2011
 Roof - damage to external membrane near parapet wall

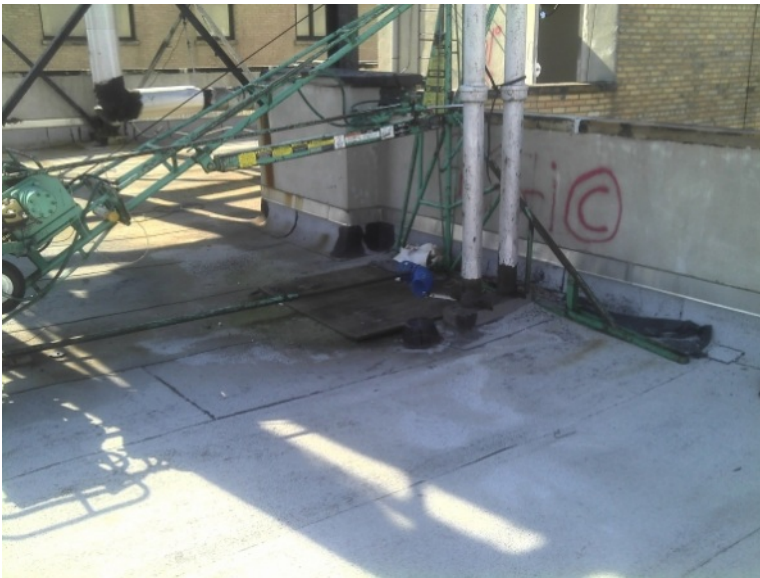
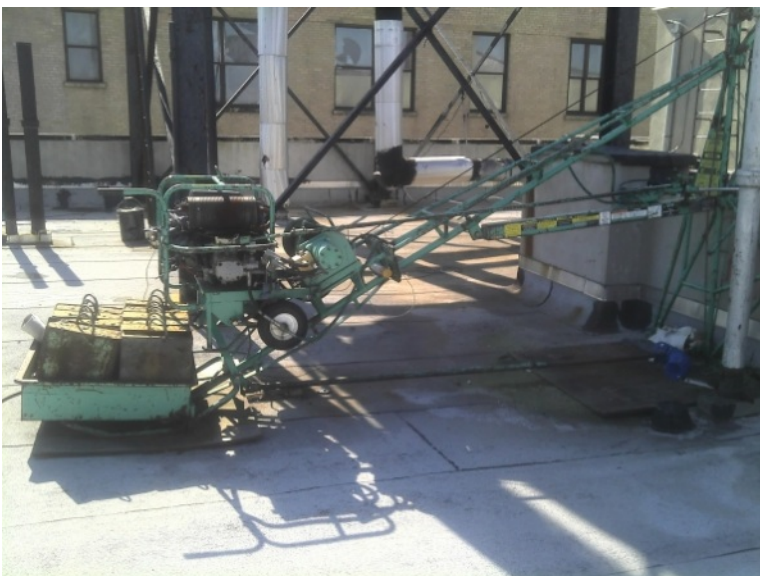
Photo 9 of 13 inadequacies
 032.jpg
 Date: 05.10.2011
 Roof - rigger hoist near parapet wall

Photo 10 of 13 inadequacies
 033.jpg
 Date: 05.10.2011
 Roof - rigger hoist near parapet wall

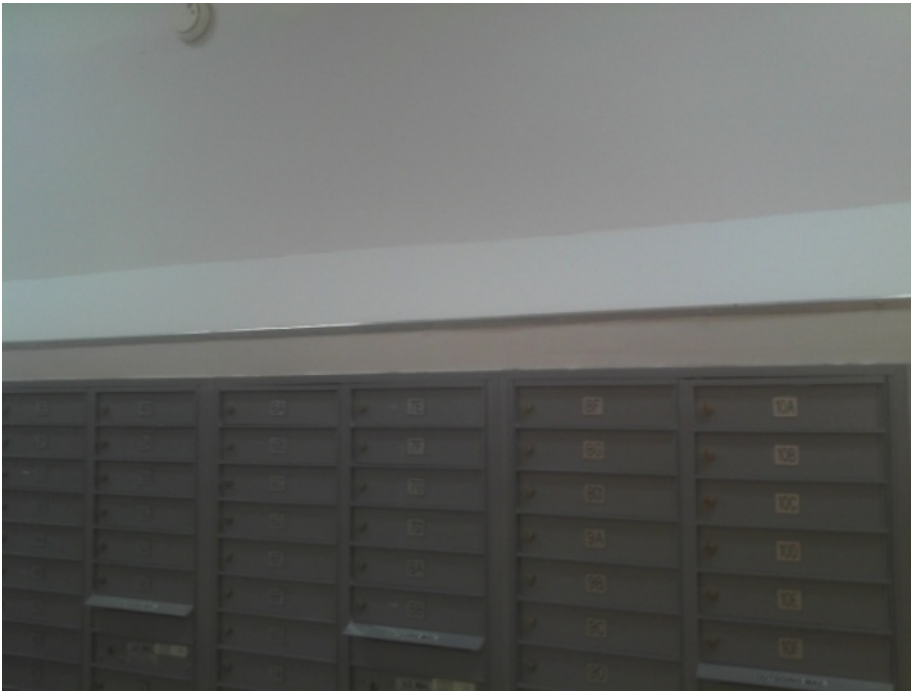
The framed out area above the recently installed mail boxes appears to not have been completed. The corner bead has yet to be finished along with an additional coating of paint.

Photo 11 of 13 inadequacies
 041.jpg
 Date: 05.10.2011
 Mail room - finish

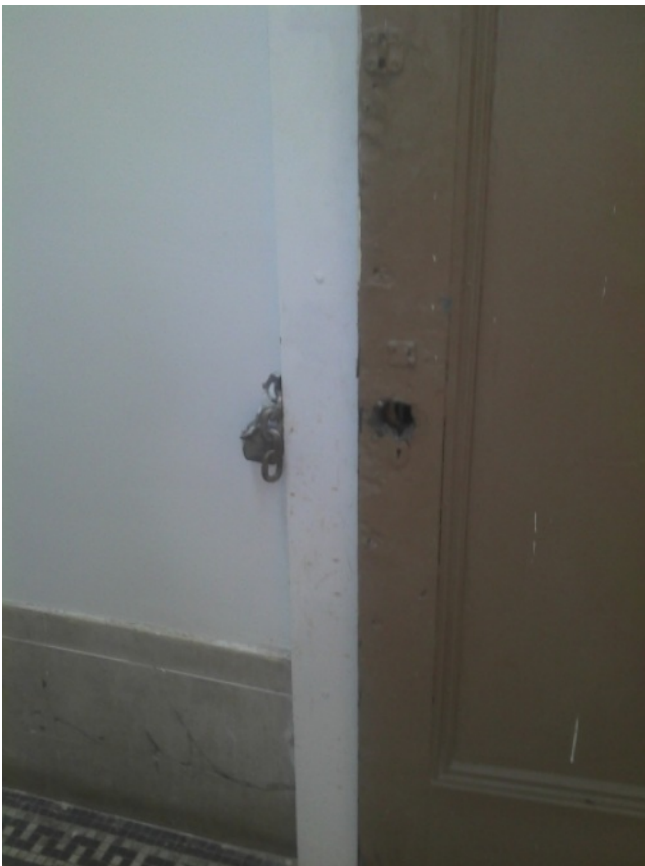
There is a storage room that is currently being secured by a chain and padlock. Proper storage and aesthetics should include the applicable hardware and lock.

Photo 12 of 13 inadequacies
 042.jpg
 Date: 05.10.2011
 Mail room - storage room door hardware missing

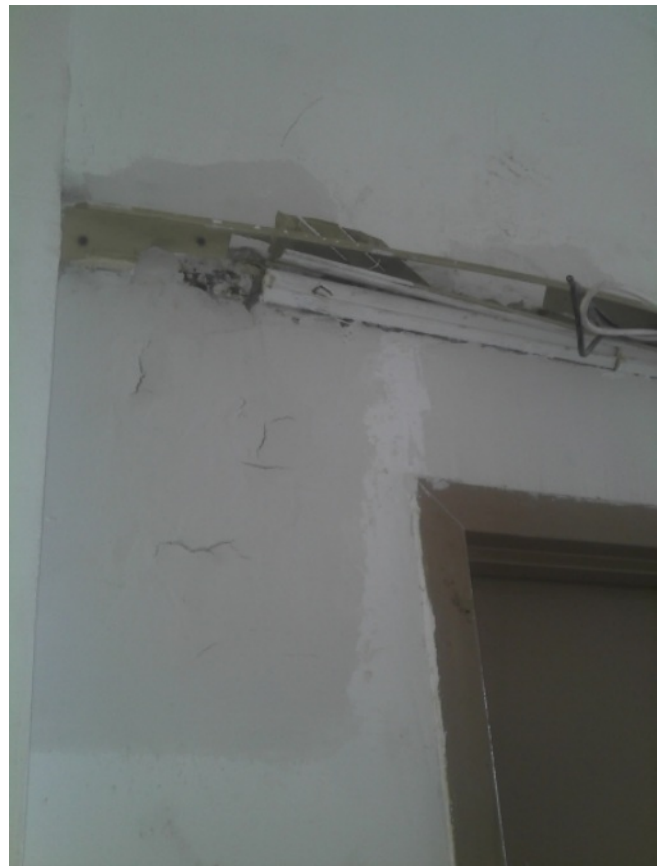
Photo 13 of 13 inadequacies
 019.jpg
 Date: 05.10.2011
 12th floor hallway - poorly finished wall "prep" and paint
