Daily report No.: 005

Site visit from 17.10.2011 11:30-01:45 o'clock

Survey Areas: Units 11F, 10F, 8F, 5F, 4F, 3F the basement, front entrance and building exterior. I was unable to gain access the following areas 12F, 9F, 7F, 6F, 2F. However the apartments I did not survey I was able to assess the external work, i.e. new doors.

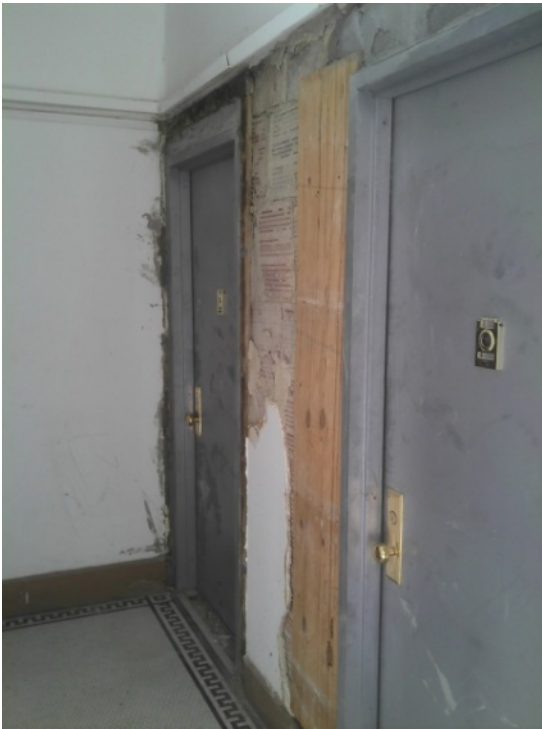
Doors and hardware - The entrance doors and hardware installation, throughout the F line, is approximately 90% complete.

Photo 1 of 9 performance level
 004.jpg
 Date: 17.10.2011
 New Doors and hardware installed 12F

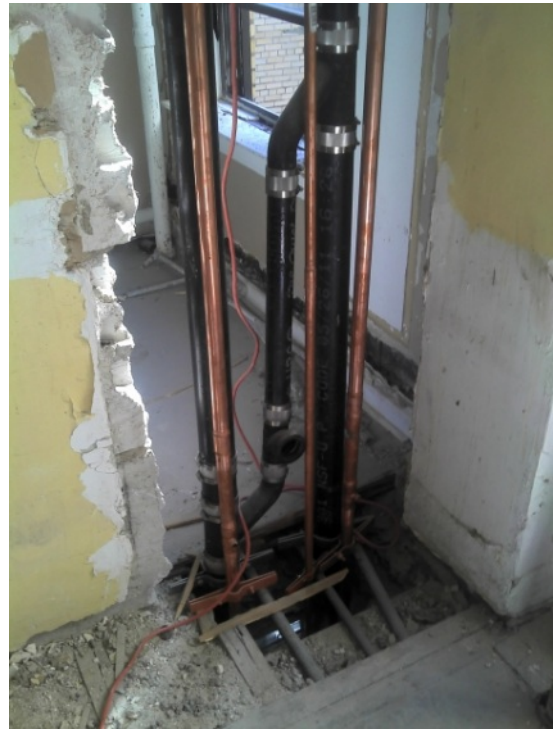
Water and waste piping – Based upon access new waste and water lines had been installed down to unit 4F. This is considering work beginning in unit 12F and working down. This includes both the bathrooms and kitchen. It appears considering my level assessment the pipes are precisely vertical.

Photo 2 of 9 performance level
 007.jpg
 Date: 17.10.2011
 11F Kitchen waste, water and gas piping

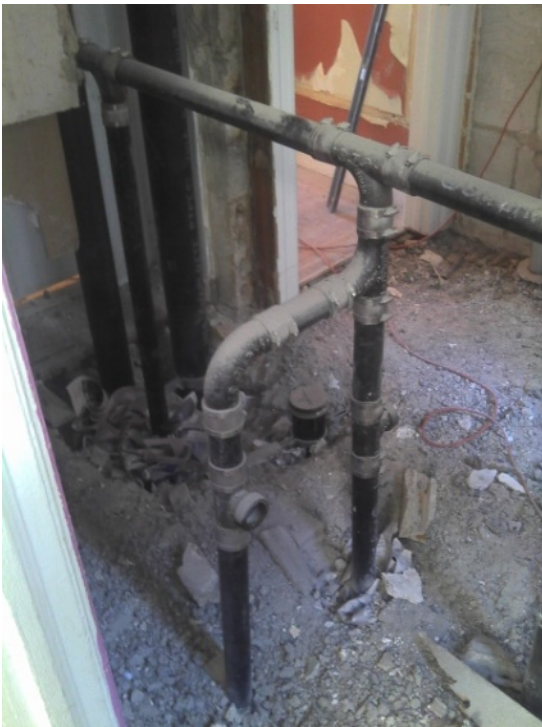
Bathrooms – Demolition in all bathrooms is complete, and Dellwood is in the process of installing domestic water and waste lines.

Photo 3 of 9 performance level
 009.jpg
 Date: 17.10.2011
 11F Bathroom piping

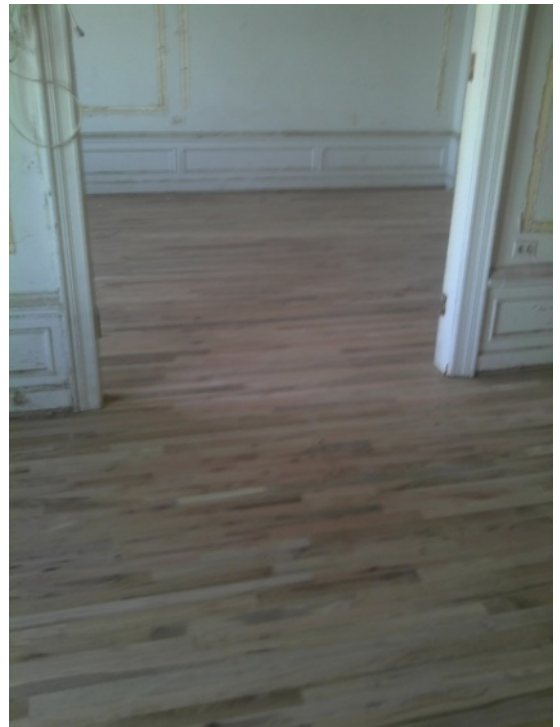
Photo 4 of 9 performance level
 019.jpg
 Date: 17.10.2011
 10F Flooring

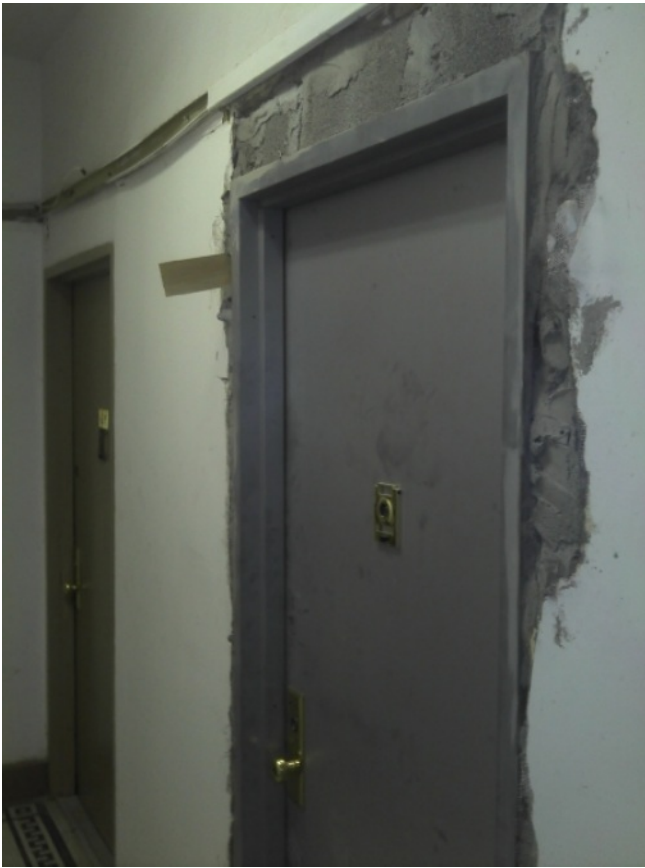
Photo 5 of 9 performance level
 031.jpg
 Date: 17.10.2011
 7F second means of egress installed

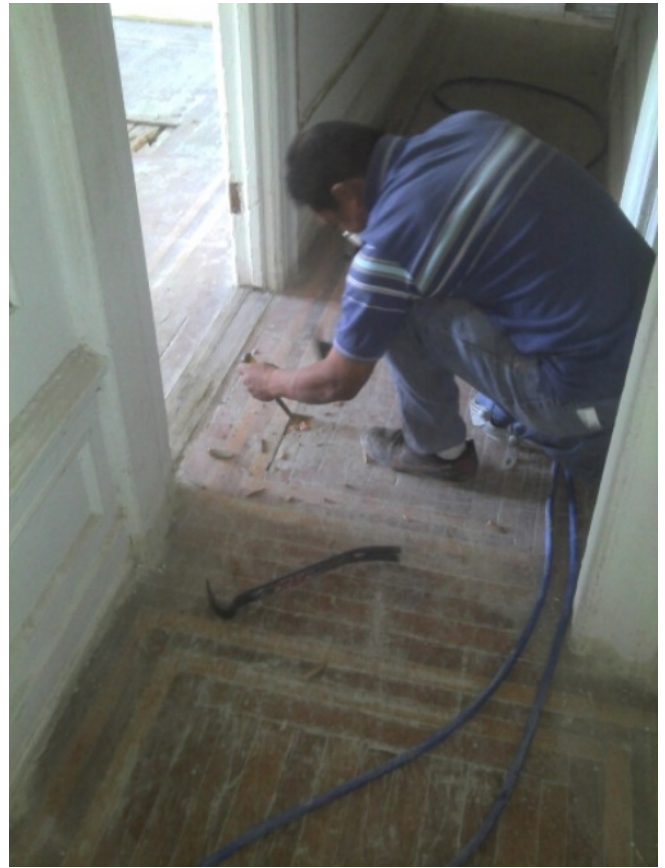
Photo 6 of 9 performance level
 033.jpg
 Date: 17.10.2011
 5F flooring work

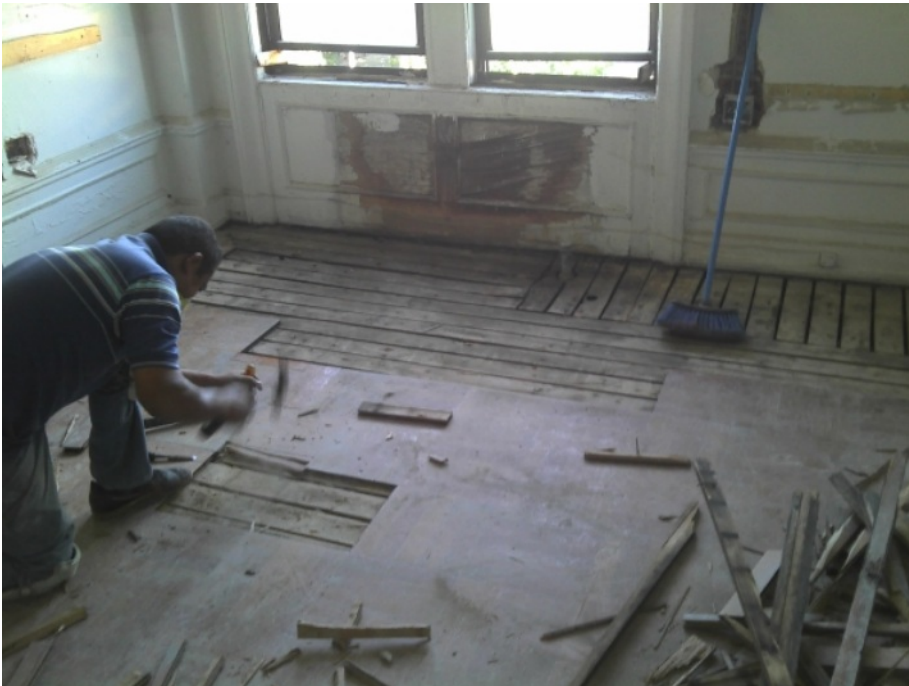
Photo 7 of 9 performance level
 077.jpg
 Date: 17.10.2011
 5F flooring work

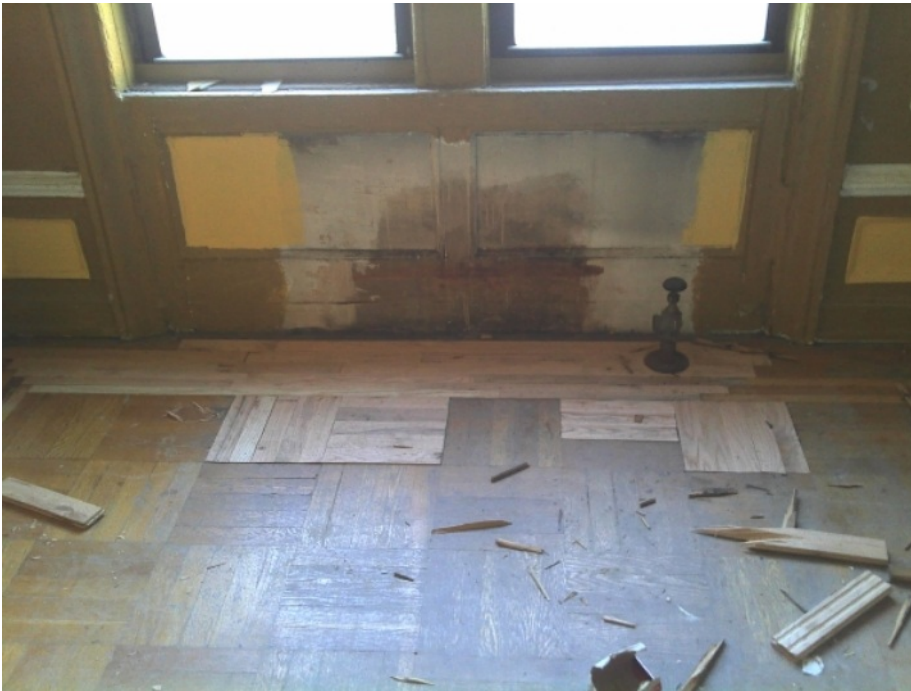
Flooring – In more than 50% of the F line units Dellwood has initiated either complete floor replacement, refinishing or selective floor replacement. The current work to selectively replace damaged flooring is quite admirable, in particular the parquet areas.

Photo 8 of 9 performance level
 080.jpg
 Date: 17.10.2011
 4F selective replacement flooring

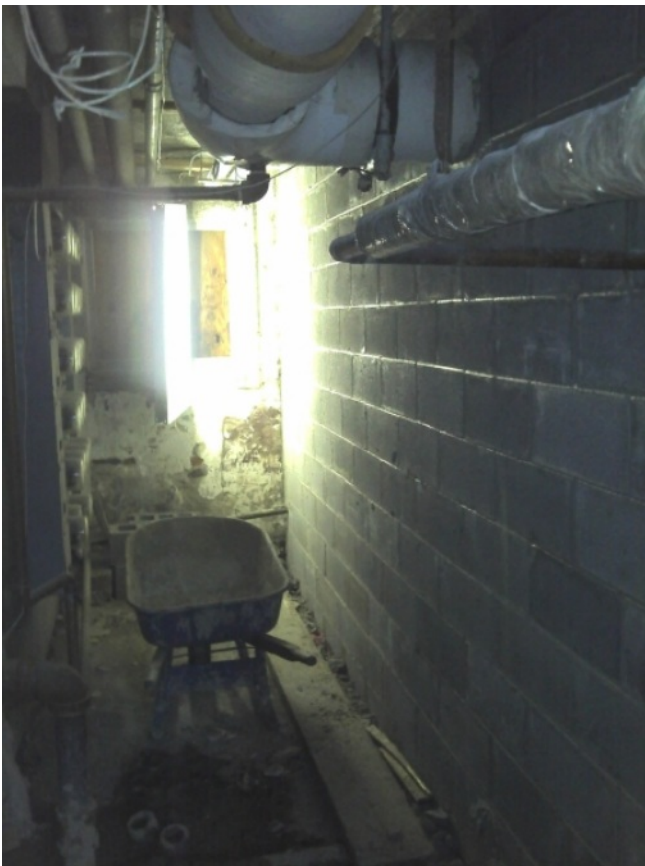
Photo 9 of 9 performance level
 093.jpg
 Date: 17.10.2011
 Cinder block wall complete in basement

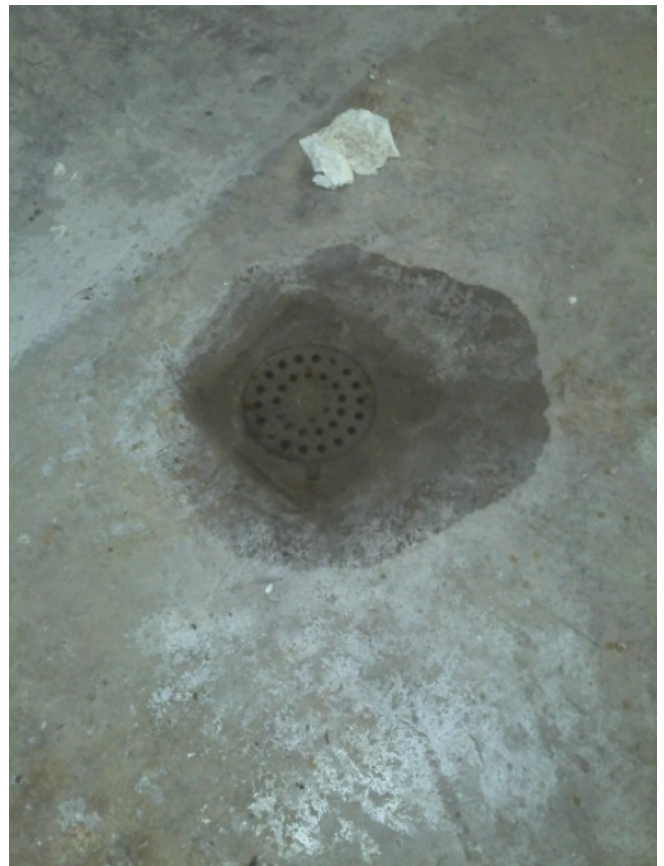
Laundry room (basement) - floor drain: A drain in the laundry room appears to be clogged based upon the stagnant water accumulated over the drain. This room is used to acquire water and pools of water are forming because of improper drainage.

Photo 1 of 3 inadequacies
 107.jpg
 Date: 17.10.2011
 Laundry Room (basement) floor drain

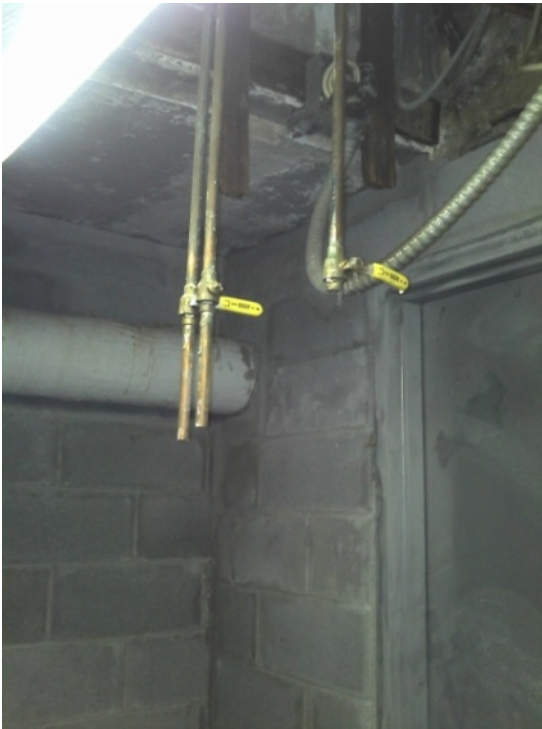
Domestic water line (basement) leaking: A new domestic water line had a fairly steady drip in the basement forming a pool of water on the floor. It appears this was only occurring the day I was at the site however it should be alleviated.

Photo 2 of 3 inadequacies
095.jpg
Date: 17.10.2011
Basement - water line leaking

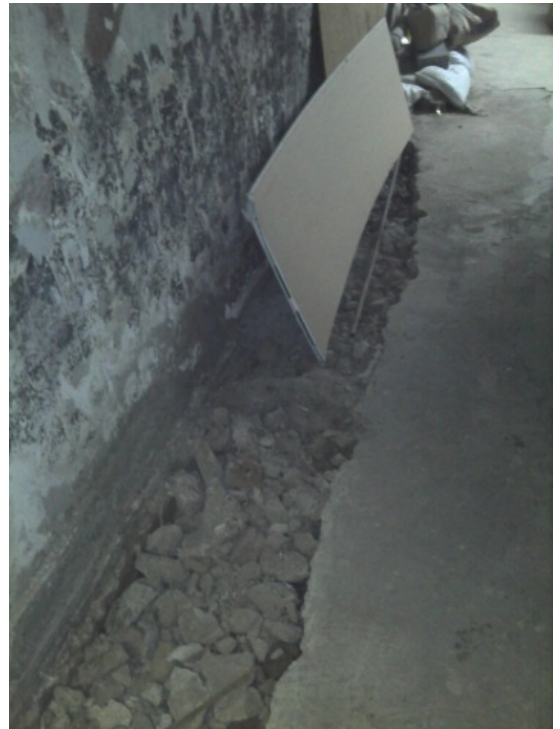
Basement floor trenching area: The area of the basement that has been trenched is not adequately protected from a potential hazard. This area needs to be properly cordoned to prevent a potential liability.

Photo 3 of 3 inadequacies
097.jpg
Date: 17.10.2011
Basement - floor trenching
