Daily report No.: 006

Site visit from 17.11.2011 03:15-04:50 o'clock

Survey Areas: Units 12F, 8F, 7F, 6F, 5F, 4F, 3F, 1F the basement, front entrance and building exterior. I was unable to gain access the following areas 11F, 10F, 9F, 2F. However the apartments I did not survey I was able to assess the external work, i.e. new doors.

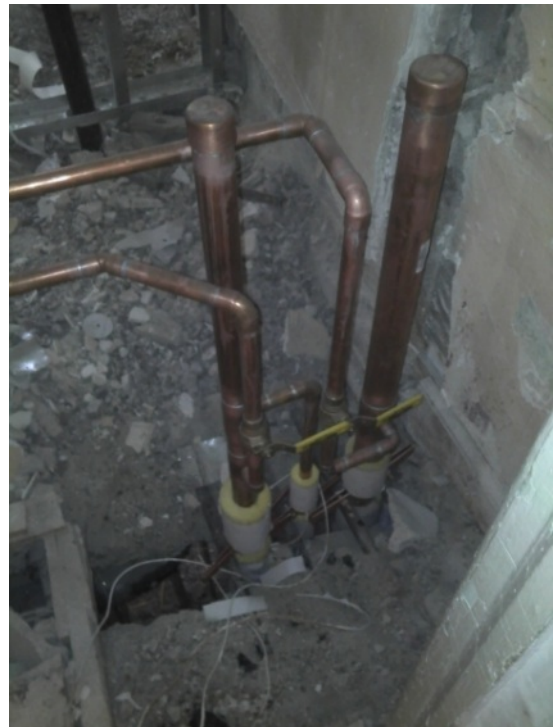
Photo 4 of 11 performance level
013.jpg
Date: 17.11.2011
12F domestic water lines with cut-off valves

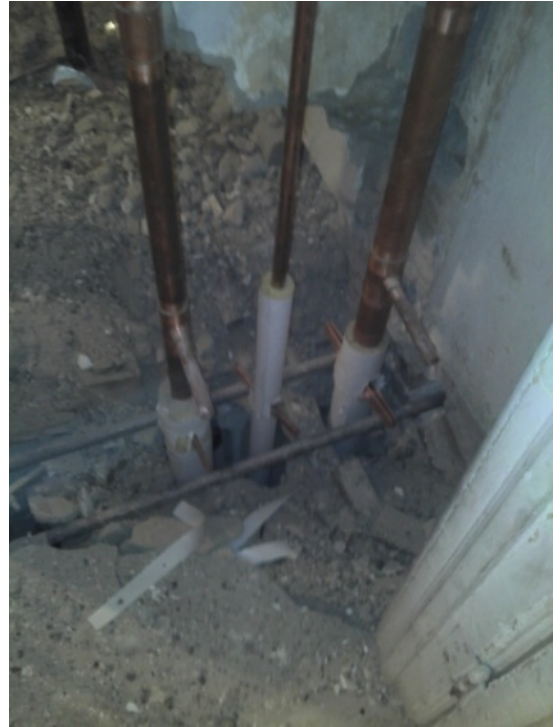
Plumbing "rough" has been installed including replacement of waste lines and domestic water lines. Plumbers were in the process of installing finish lines beginning in apartment 5F. Shut-off valves for the water line had yet to be installed in apartments 3F and 1F. I assume these valves have yet to be installed in apartment 2F, as well.

Photo 11 of 11 performance level
065.jpg
Date: 17.11.2011
3F domestic water with no cut-off valves

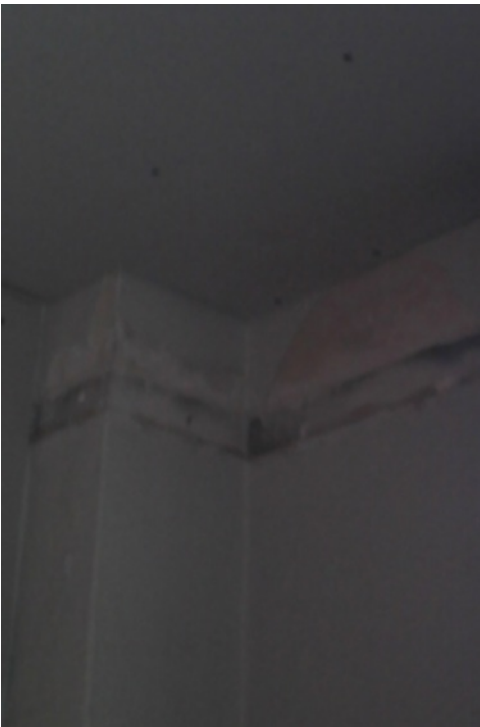
Demolition of ceiling molding: Will this molding be replaced?

Photo 1 of 7 inadequacies
025.jpg
Date: 17.11.2011
Demolished moldings 9F

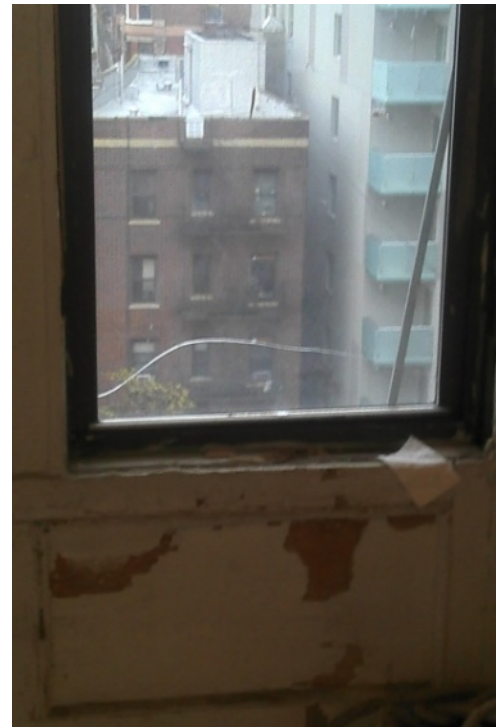
Cracked Window (Apartment 8F): I noticed that a window in the traditional dining area had been cracked. This pane needs to be replaced.

Photo 3 of 7 inadequacies
029.jpg
Date: 17.11.2011
Cracked window 8F

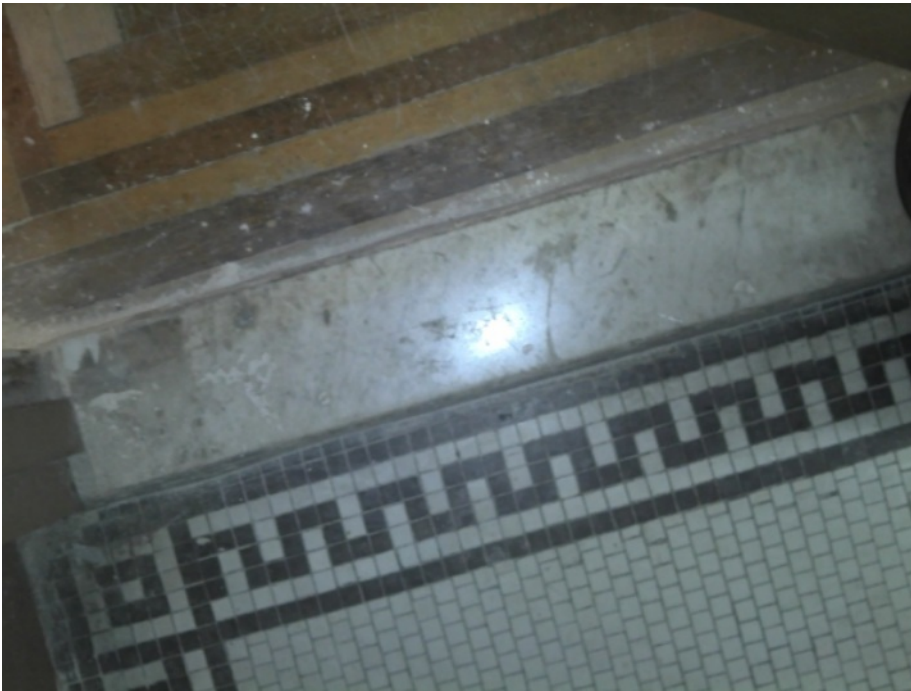
Entrance saddle (Apartment 4F): I noticed the entrance saddle for apartment 4F significantly raised more so than the other units. This, in my opinion, is a severe tripping hazzard and should be addressed.

Photo 4 of 7 inadequacies
 064.jpg
 Date: 17.11.2011
 Entrance door "saddle" severe trip hazzard

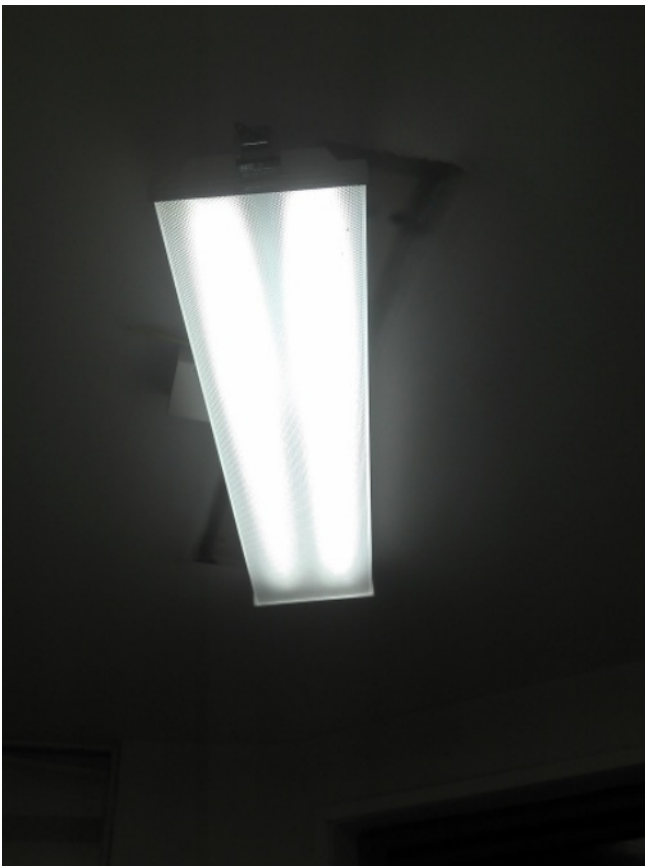
Light ajar (Forth floor hallway): Adjacent to the elevator the ceiling light appears to be ajar and should be checked to ensure that it has been installed and/or remains secure to the ceiling.

Photo 5 of 7 inadequacies
 067.jpg
 Date: 17.11.2011
 Light ajar fourth floor near elevator

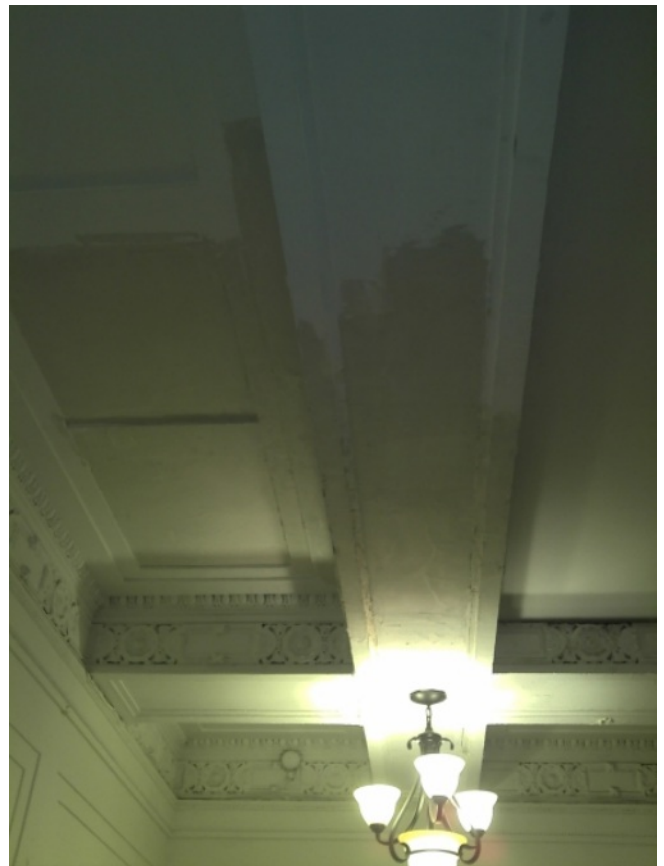
Unpainted ceiling (lobby): It appears the lobby ceiling has been patched in several spots in the lobby. However these areas have not been properly sanded and painted.

Photo 6 of 7 inadequacies
 069.jpg
 Date: 17.11.2011
 Unpained ceiling areas lobby

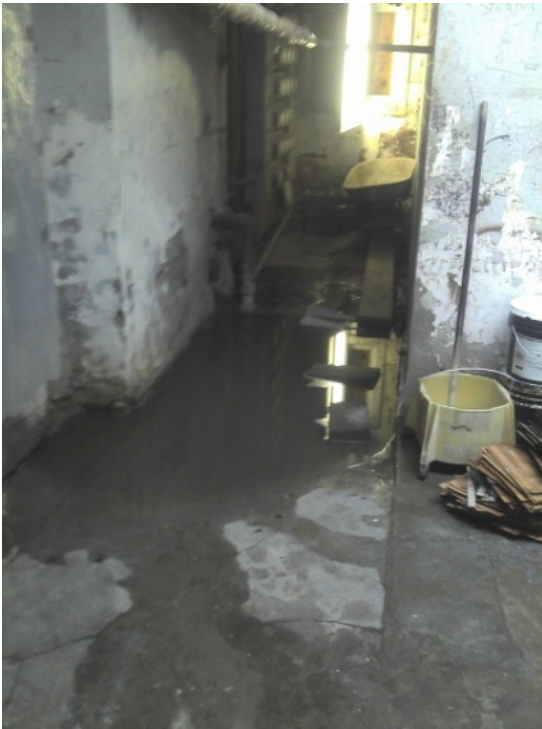
Area - Boiler Room (basement) - floor drain: In my last report (#5) I illustrated water pooling in the basement. Since my last visit this issue has yet to be rectified. Based on an extensive conversation with the plumber he acknowledges the problem and will cure the issue. Based on his description the masons erecting the cinder block wall used the drain and unfortunately mortar debris has clogged the drain. It can not be "snaked-out" because of the heavy mortar. Thus the plumber must replace a portion of the drain.

Photo 7 of 7 inadequacies
071.jpg
Date: 17.11.2011
Water pooling in basement (boiler room)

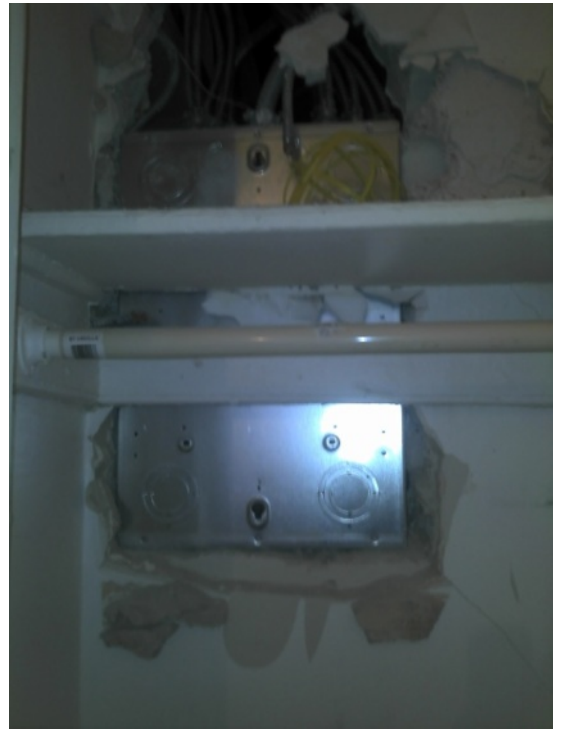
Electrical Box: In each of the units the newly installed electrical boxes need to be covered within the hall closet.

Photo 7 of 7 inadequacies
020.jpg
Date: 17.11.2011
12F Hall closet electric box back
