DAILY REPORT NO: 007

Site Visit: November 30, 2011 (1:38pm to 3:30pm)

Survey Areas: Units 11F, 7F, 6F, 2F, 1F the basement, front entrance, building exterior. I was unable to gain access to the following areas: 12F, 10F, 9F, 8F, 5F, 4F, and 3F. In addition I was unable to gain access to the roof; however I did view the roof from a window via the bulkhead.

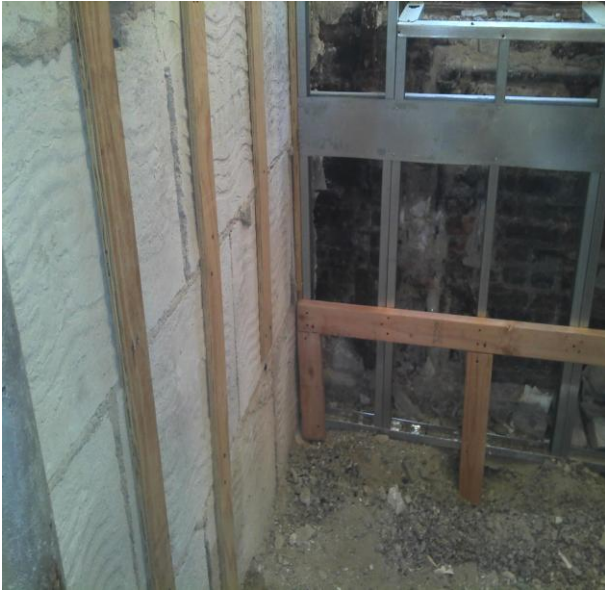
Photo 1 of 5 performance level
Date: 11-3-2011
11F wall furring

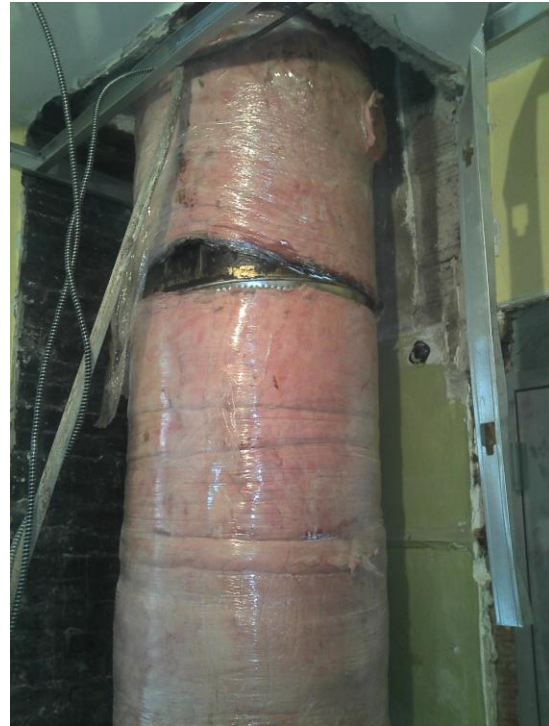
Photo 2 of 5 performance level
Date: 11-3-2011
11F trash chute

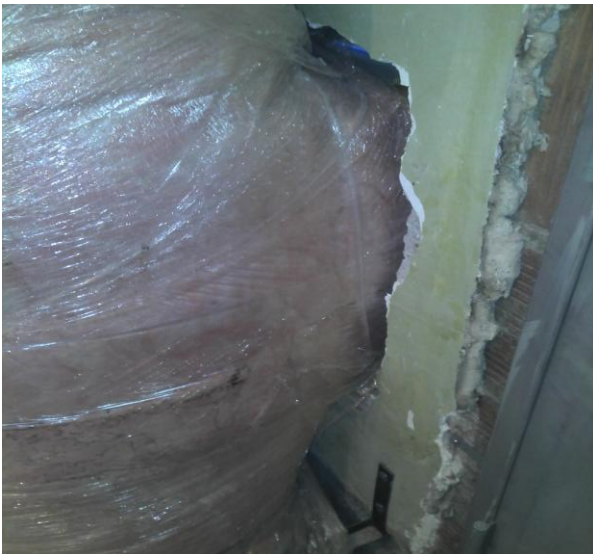
Photo 3 of 5 performance level
Date: 11-3-2011
7F trash chute

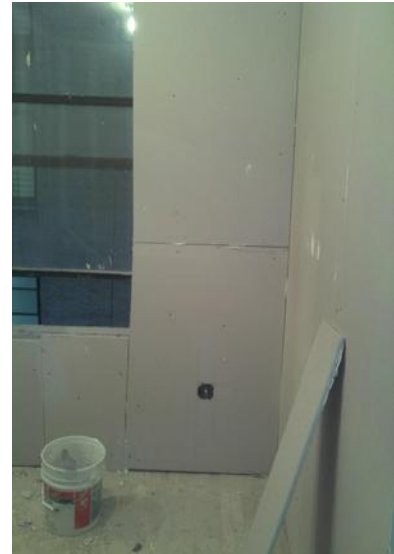
The contractor continues to work from the top unit to the bottom. Drywall is currently being installed in the room originally designated as a maids quarters. Therefore the previously exposed plumbing and electrical wiring is being covered. The contractor continues to tape and patch drywall.

Photo 4 of 5 performance level
Date: 11-3-2011
6F drywall installation

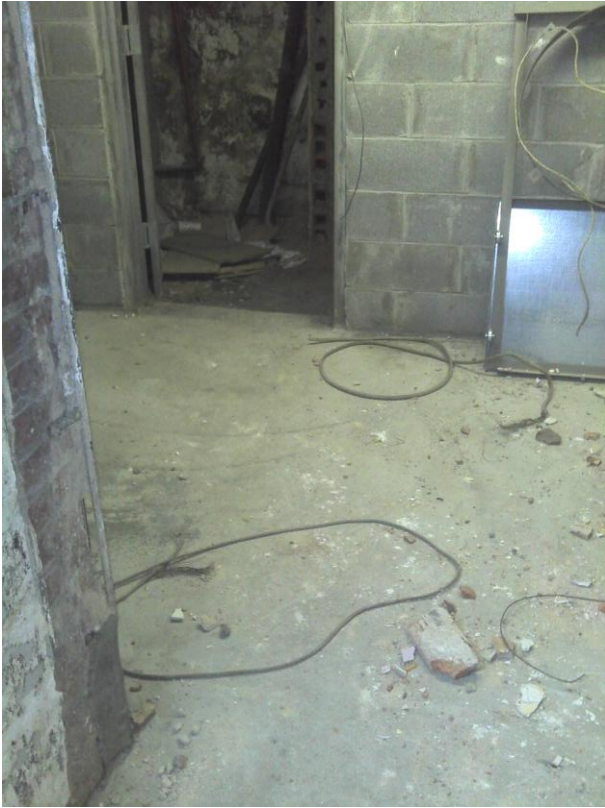
Photo 3 of 5 performance level
Date: 11-3-2011
Basement - new concrete floor

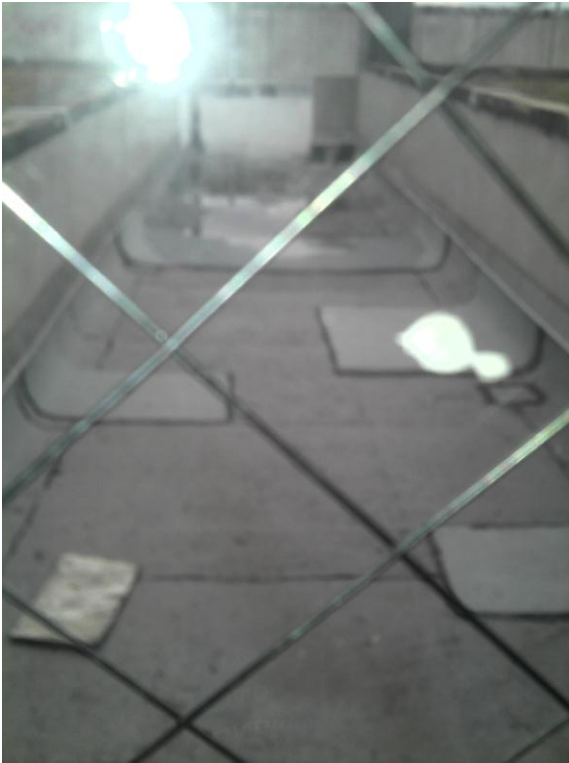
Roof: Previously I noted several breaches to the roof membrane which caused leaking to internal portions of the building. I also noted that access to the roof was not secure. Upon my visit access to the roof was secure and it appeared that patching occurred to rectify the cuts to the membrane. I hope this work does not void the warranty.

Photo 1 of 6 inadequacies
Date: 11-30-2011
Roof patching

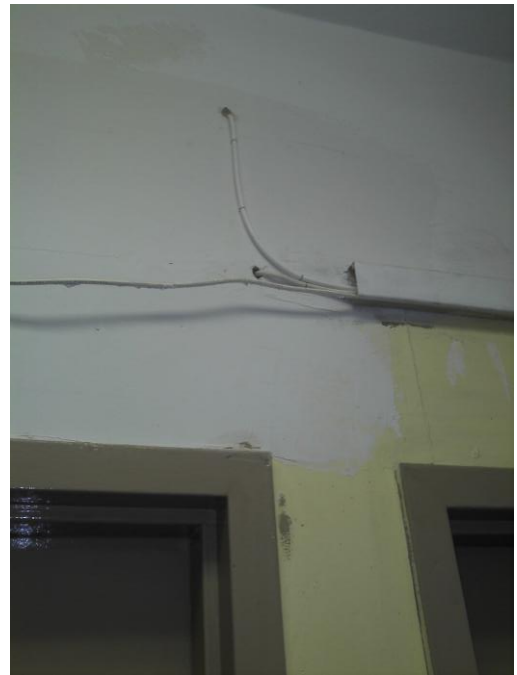
Cable wiring (apartment entrance): a number of units, in particular the units that have been completed have loose cable wiring above each entrance. A significant number of these units exist. These wires should be enclosed by wiring molding which appears to have been installed some time ago.

Photo 2 of 2 inadequacies
Date: 11-30-2011
Loose cable wires

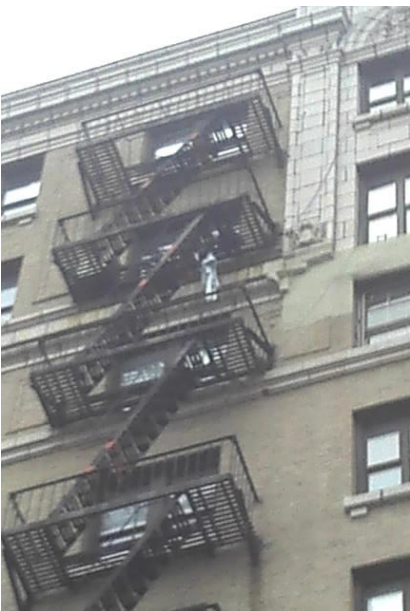
Fire escape debris: Debris currently hangs from the fire escape near 11F. This debris should be removed.

Photo 3 of 6 inadequacies
Date: 11-30-2011 - Debris from fire escape

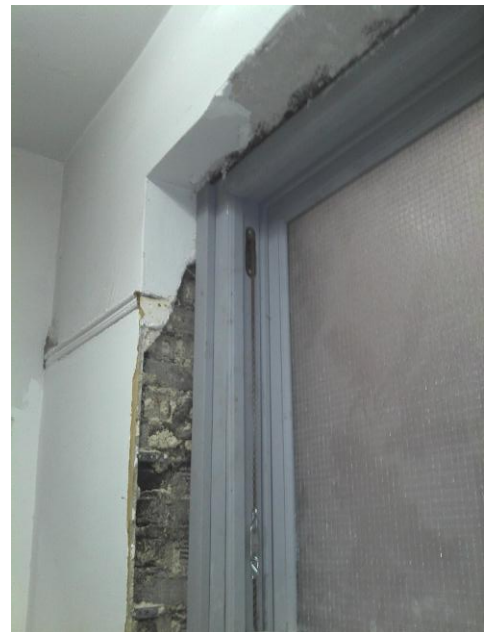
New hall windows: New windows have been installed in the “completed areas. However the framing has yet to be completed.

Photo 4 of 6 inadequacies
Date: 11-30-2011 - New window (hall)

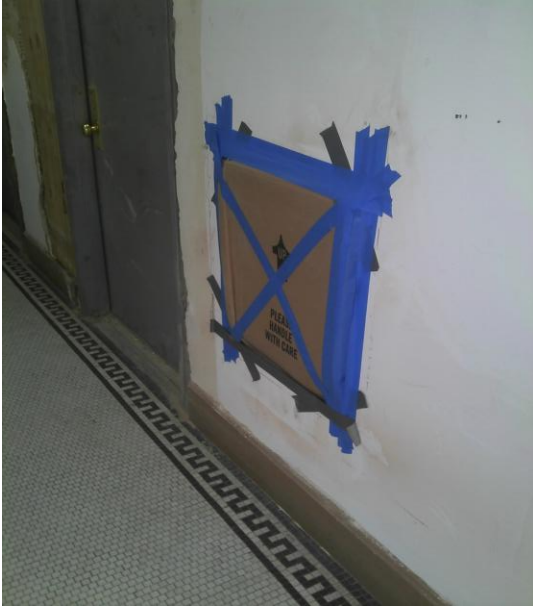
Photo 5 of 6 inadequacies
Date: 11-30-2011 – Trash chute access needs
Caution tape.

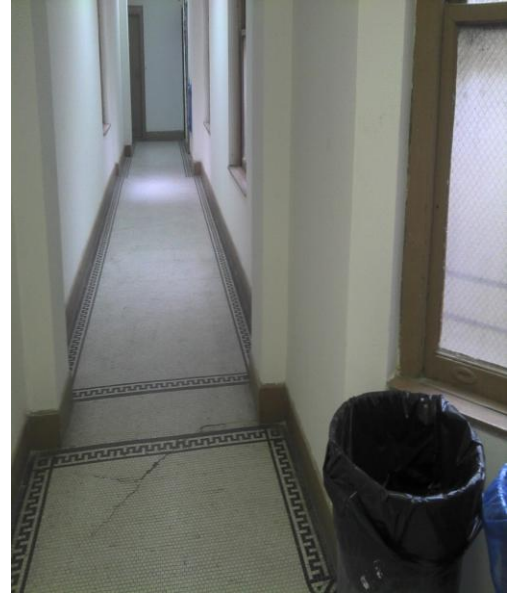
Photo 6 of 6 inadequacies
Date: 11-30-2011 – Existing trash cans to in
Comparison to trash chute area.
