DAILY REPORT NO: 009

Site Visit: January 6, 2012 (9:30am to 1:30pm)

Survey Areas: Units 5F, 4F, 9E, 6G, the basement, front entrance, building exterior. I was unable to gain access to the following areas: 12F, 11F, 10F, 9F, 8F, 7F, 6F, 3F, 2F and 1F.

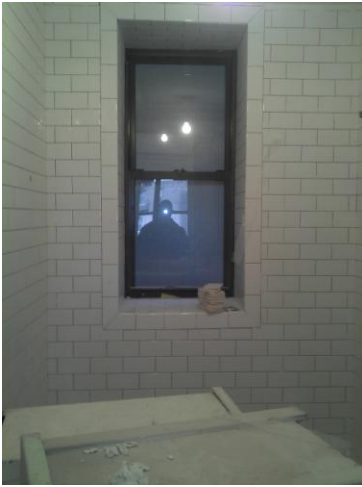
Unit 5F: Electrical, framing, plumbing, wood flooring have all been installed. In the full bathroom the tub has been set and the tile installed. The tile has yet to be grouted and ceramic tile has yet to be applied to the floor. The kitchen remains bare, without cabinets and the flooring has yet to be installed.

Photo 1 of 3 – Performance Level – 5F bathroom

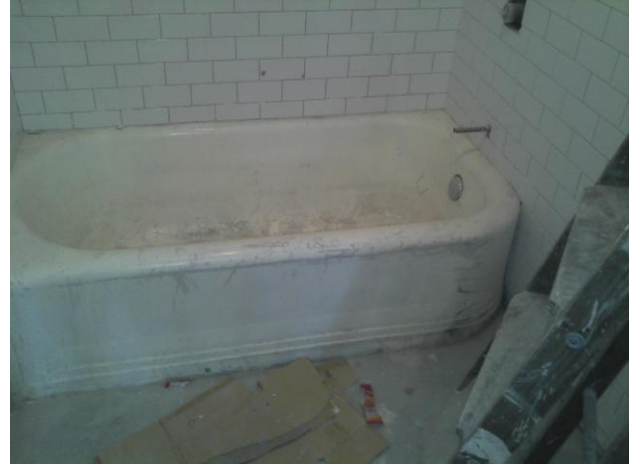
Unit 4F: This unit is in the same state as unit 5F.

Photo 2 of 3 - Performance level – 4F bathroom

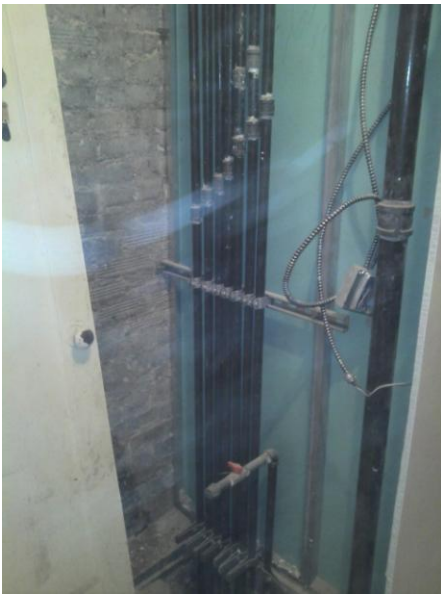
Photo 3 of 3 – Performance Level – 5F new gas lines

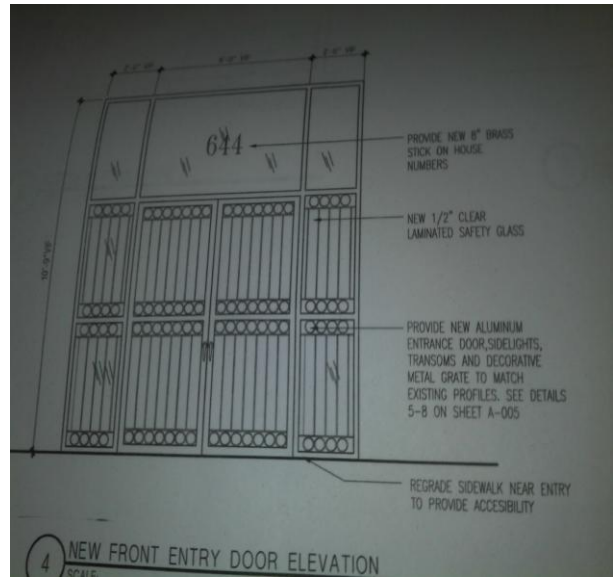
According to the design documents the front entrance doors were to encompass decorative metal grates to mimic the original doors. This application has yet to be installed or was eliminated during value engineering.

Photo 1 of 2 – Inadequacies – Plans Front Entrance
