Daily report No.: 001

Site visit from 17.08.2011 09:30-12:30 o'clock

Performance level: Wednesday, August 17th was my first site visit and thus my initial focus was on the overall process and scope of the participants in the redevelopment of 644 Riverside Drive. Based on my initial visit please find below my findings:
(see photos)

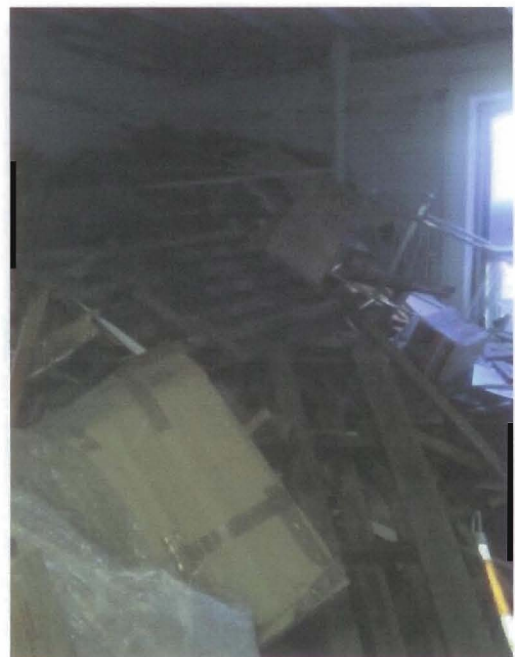
In consideration of debris being moved from the upper units to the first floor, the general contractor is frequenting the elevator. Unfortunately they are not using one designated elevator but both during the day deterring residents from gaining access to their apartments. In addition the type of debris being removed needs to be contained, however remnants of dust are being thrust into the air and it is imperative that the elevator is thoroughly cleaned. The contractor should only use one elevator in deference to the residents. In addition I would recommend that the general contractor employ a debris chute, which must be approved by DOB, to expedite debris removal.

Photo 8 of 12 performance level
043.jpg
Date: 05.10.2011
1F Living Rm. debris staging area

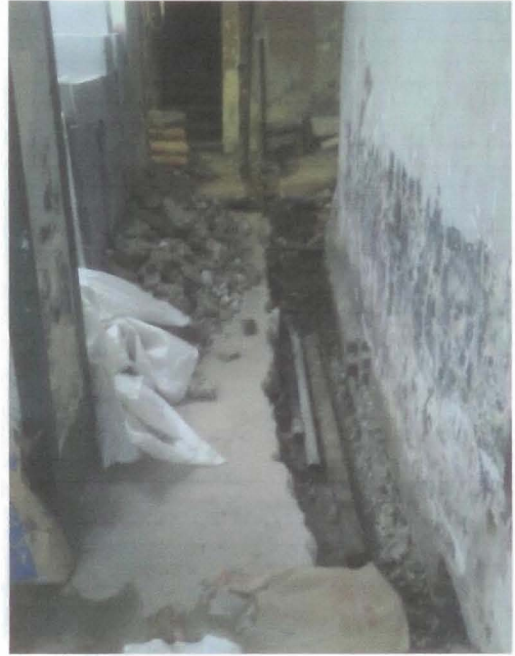
A portion of the basement floor has been trenched for installation of a drain line. A cinder block wall enclosure is also being installed and is approximately 80% complete. It appears the area will encompass utility meters. Considering the floor has been trenched the appropriate safety measures should be taken to cordon off this area so as to not incur an accident.

Photo 10 of 12 performance level
050.jpg
Date: 05.10.2011
Basement - trenching for new pipes

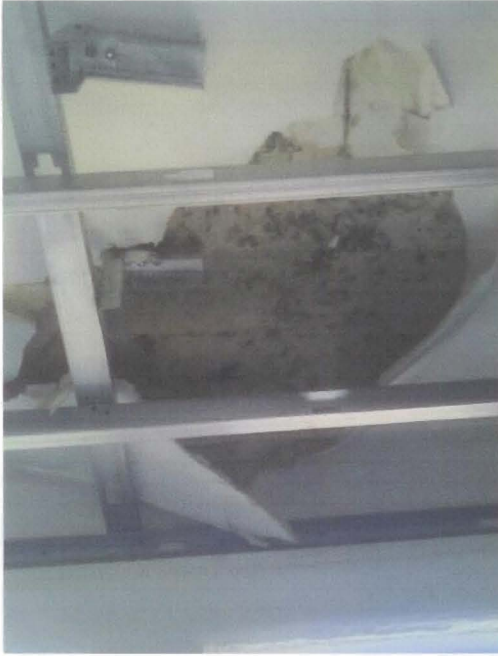
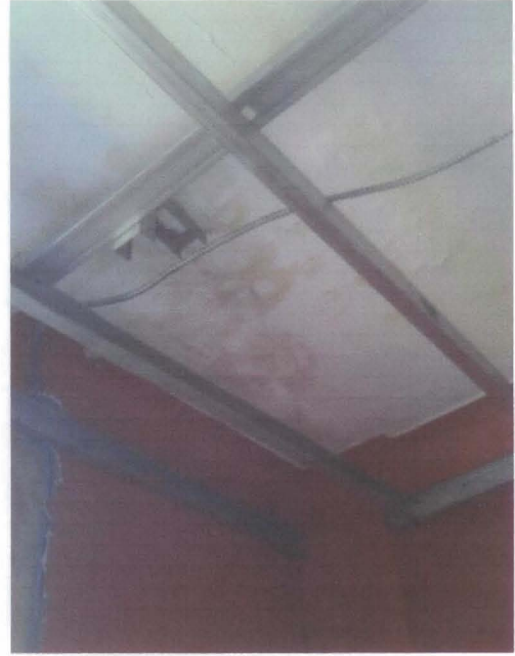
Inadequacies (general): Water Damage:
 (see photos) There is a significant amount of water damage that is conspicuous on the 12th floor ceilings and in the hallway around windows. Per my inspection I found the following:

Photo 1 of 13 inadequacies
008.jpg
Date: 05.10.2011
12F ceiling water damage liv. Rm.

Photo 2 of 13 inadequacies
011.jpg
Date: 05.10.2011
12F ceiling water damage liv. Rm.

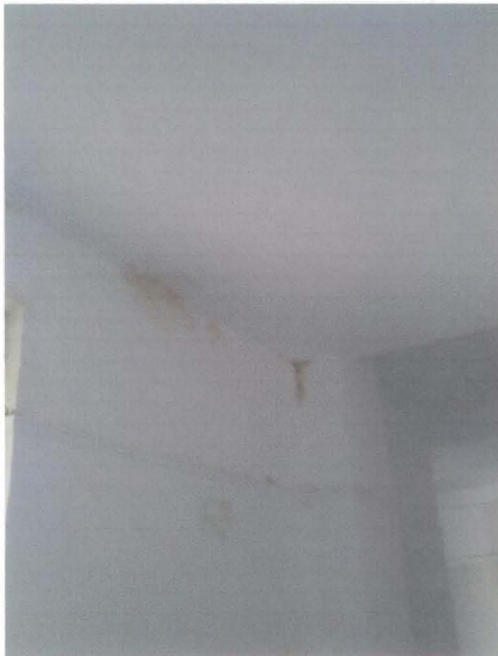
Windows (water damage) – I noticed that tuck pointing and lintel repair around the windows had not taken place in the court yard area. I believe the water that has appeared in the hallway is from breaches in the brick façade.

Photo 3 of 13 inadequacies
014.jpg
Date: 05.10.2011
12th floor hallway water damage

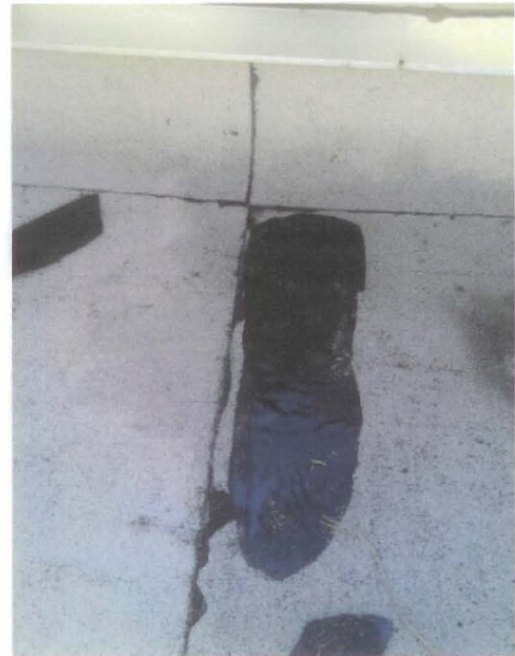
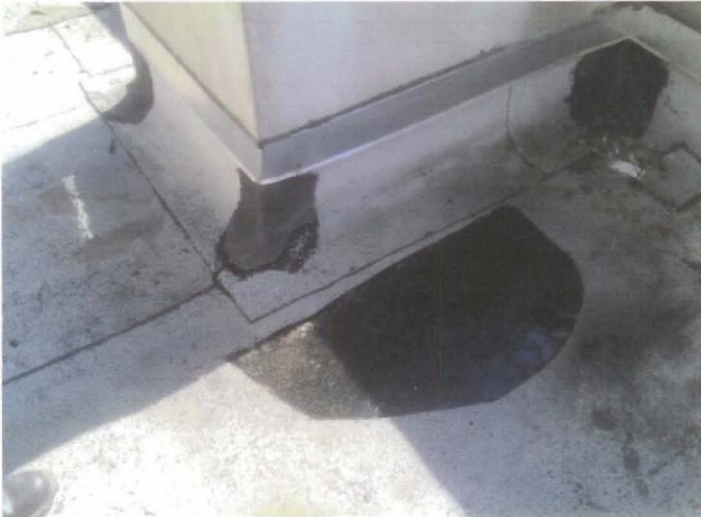
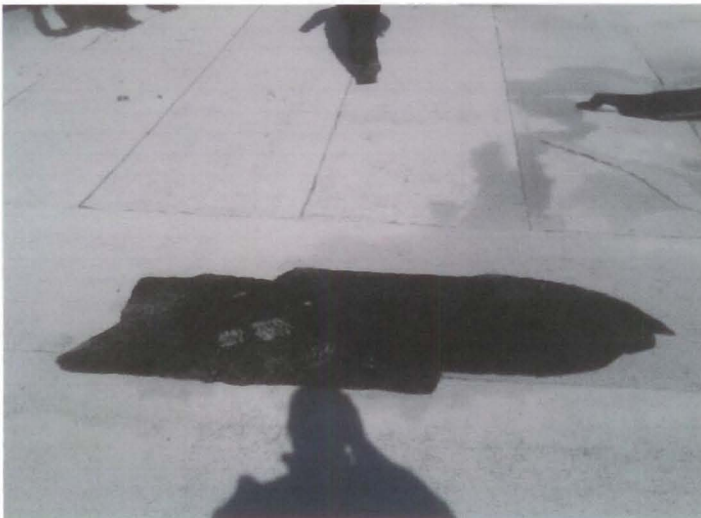
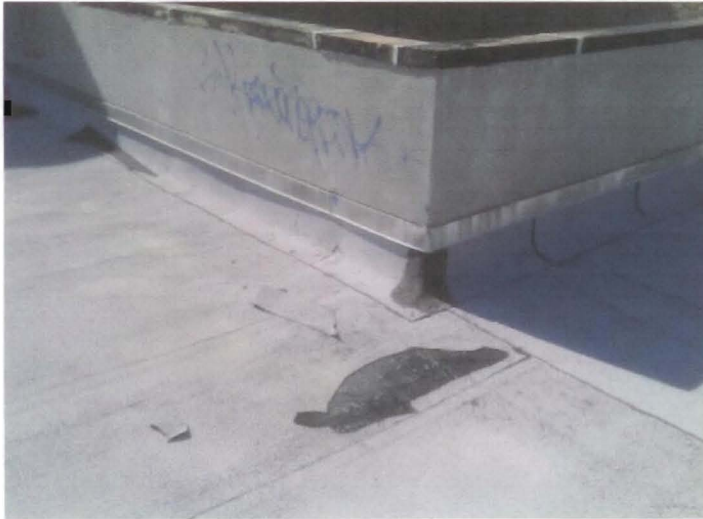
Roof damage – Several areas on the roof illustrated severe breaches in the roofs top membrane. These breaches, in my opinion, were not from customary ware but purposeful or accidental tears. In considering the later there are two possible scenarios that may have led to this damage. One, a rigger hoist has been placed on the roof. If the hoist is not properly moved or is placed on the roof without proper protection is will damage the top membrane of the roof. Secondly, based on the graffiti seen on parapet walls the roof is inadequately secured. This could result in someone making cuts in the top membrane. Both are plausible scenarios pertaining to the roof damage.

Photo 4 of 13 inadequacies
022.jpg
Date: 05.10.2011
Roof - damage to external membrane

Photo 5 of 13 inadequacies
 021.jpg
 Date: 05.10.2011
 Roof - damage to external membrane

Photo 6 of 13 inadequacies
 024.jpg
 Date: 05.10.2011
 Roof - damage to external membrane

Photo 8 of 13 inadequacies
029.jpg
Date: 05.10.2011
Roof - damage to external membrane near parapet wall

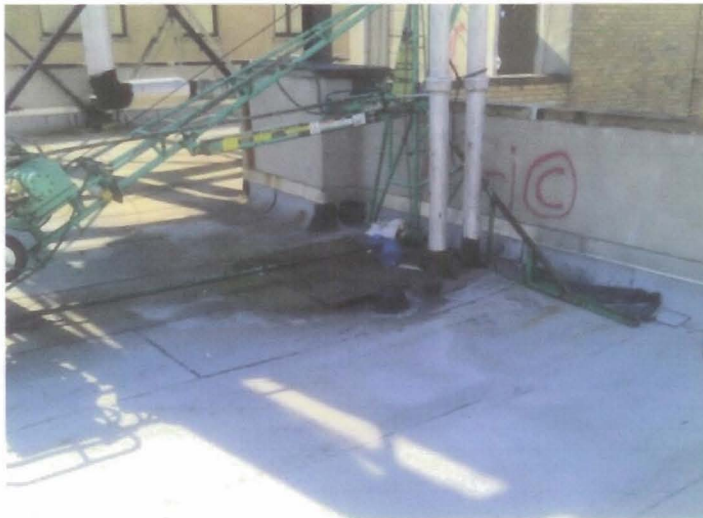
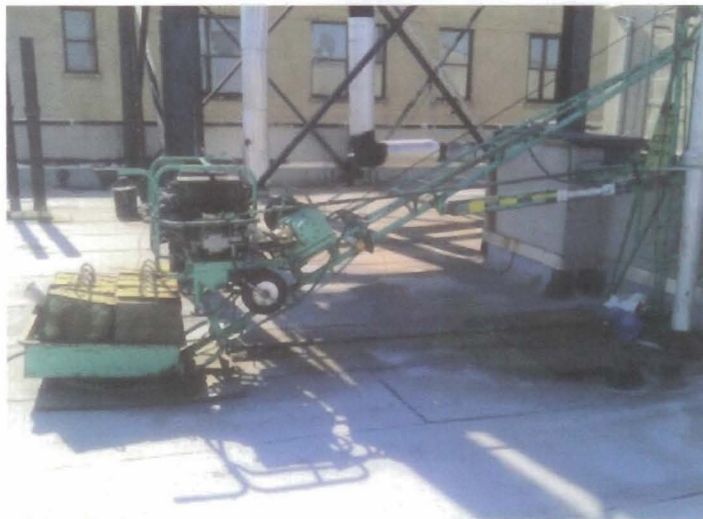
Photo 9 of 13 inadequacies
032.jpg
Date: 05.10.2011
Roof - rigger hoist near parapet wall

Photo 10 of 13 inadequacies
033.jpg
Date: 05.10.2011
Roof - rigger hoist near parapet wall

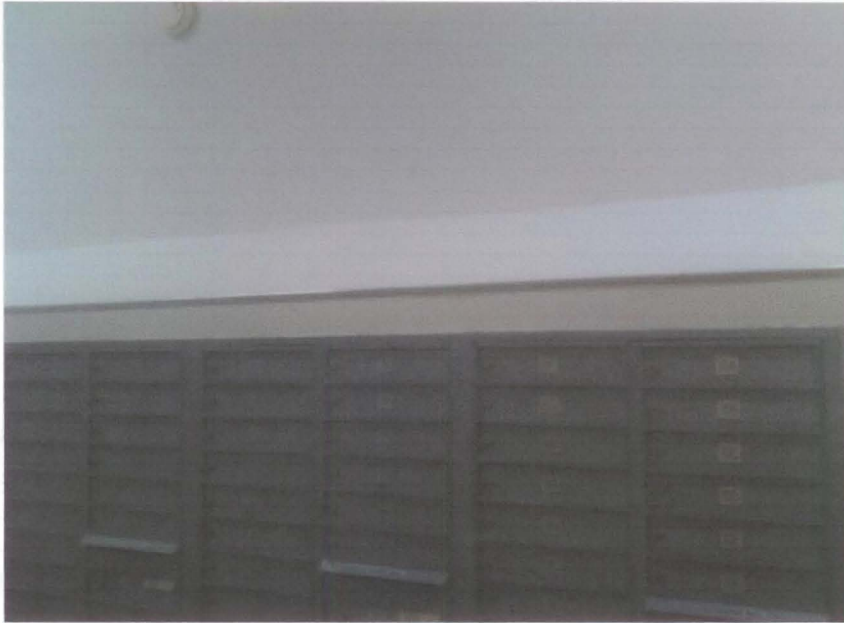
Mail Box Room:
 The framed out area above the recently installed mail boxes appears to not have been completed. The corner bead has yet to be finished along with an additional coating of paint.

Photo 11 of 13 inadequacies
041.jpg
Date: 05.10.2011
Mail room - finish

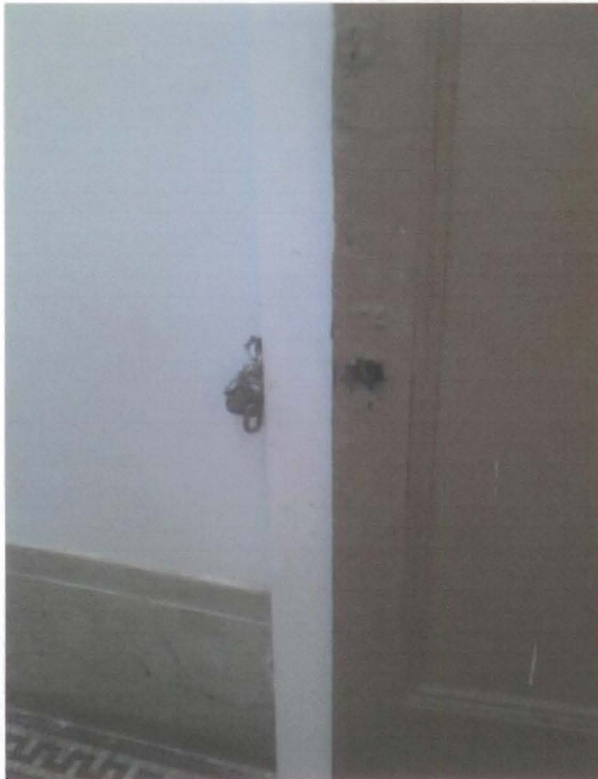
There is a storage room that is currently being secured by a chain and padlock. Proper storage and aesthetics should include the applicable hardware and lock.

Photo 12 of 13 inadequacies
042.jpg
Date: 05.10.2011
Mail room - storage room door hardware missing

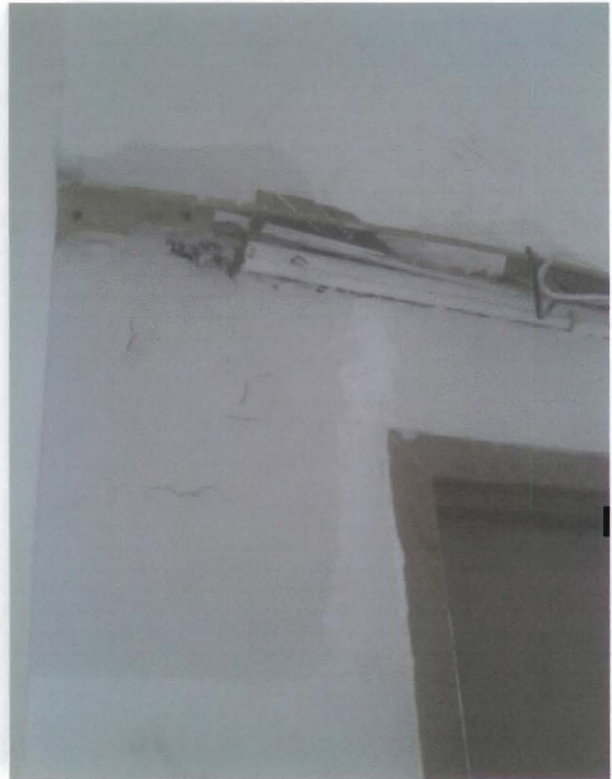
Photo 13 of 13 inadequacies
019.jpg
Date: 05.10.2011
12th floor hallway - poorly finished wall "prep" and paint

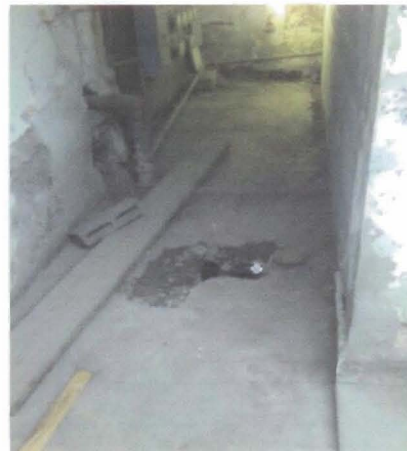
Area - Boiler Room (basement): It appears that the plumber has commenced work to rectify the severe lack of drainage in this area. Unlike other visits water was not pooling around the drain, however the drain pipe was full and the concrete and grate around the drain pipe had been removed. This indicates work to remedy the problem.

Photo 4 of 4 – Performance Level – basement drain

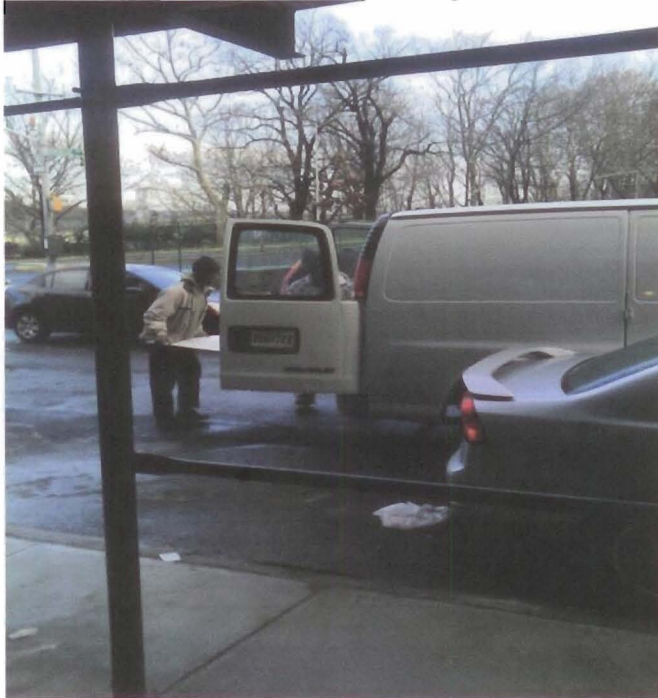
Unit 1F Staging Area: This unit has been a staging area for debris and supplies for the current F line job. Upon survey this day windows and sheet rock were present in the unit. In addition two (2) laborers were moving items in the unit. During a second visit to the unit during the same day we found laborers taking drywall stored in the unit and placing them in a fan and taking the supplies off site. This is extremely concerning. Generally building supplies that are stored on the property have been paid for by that property's construction budget and by all means should not be used at other sites. This breaches the construction contract and is ethically egregious. If the contractor is storing items at the site for their other jobs SHUHAB needs to be informed at once. I illustrated this issue to Barbara Malpica and she informed me that she would question Dellwood concerning this issue immediately.

Photo 1 of 1 Inadequacies – dry wall being taken from building

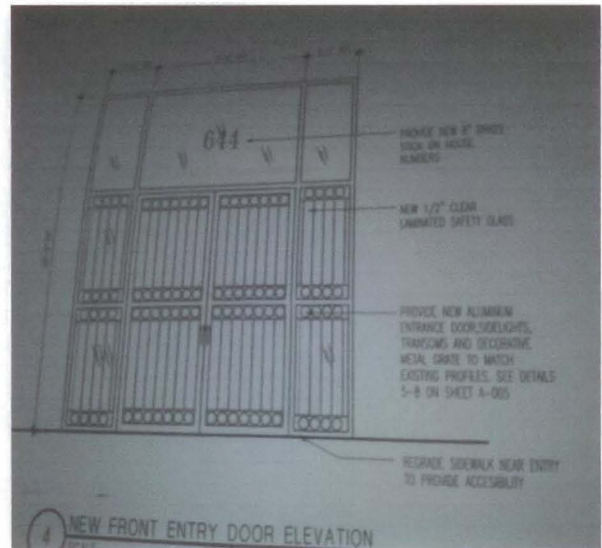
According to the design documents the front entrance doors were to encompass decorative metal grates to mimic the original doors. This application has yet to be installed or was eliminated during value engineering.

Photo 1 of 2 – Inadequacies – Plans Front Entrance
