Daily report No.: 003

Site visit from 14.09.2011 09:40-12:40 o'clock

Performance level: (see photos) Thursday, September 14th – My presence was requested on site for an HPD/DASE inspection. This inspection primarily was to ascertain the physical state of the F line water and waste lines.

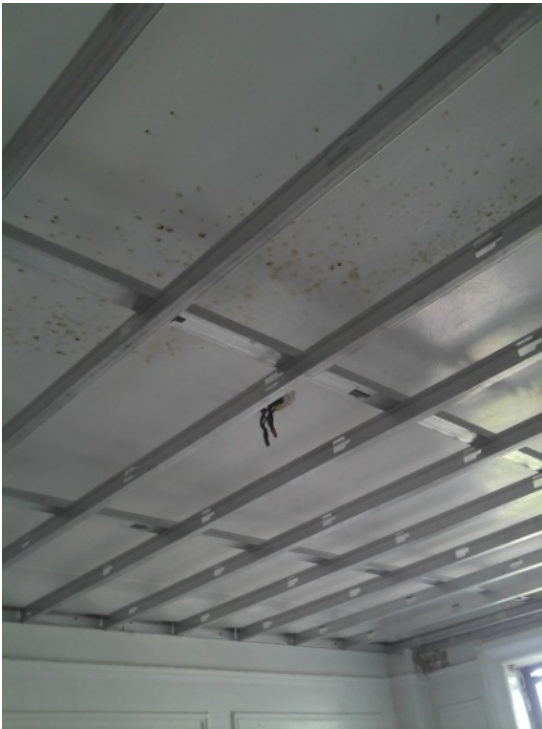
Photo 1 of 5 performance level
 040.jpg
 Date: 14.09.2011
 11F ceiling frame

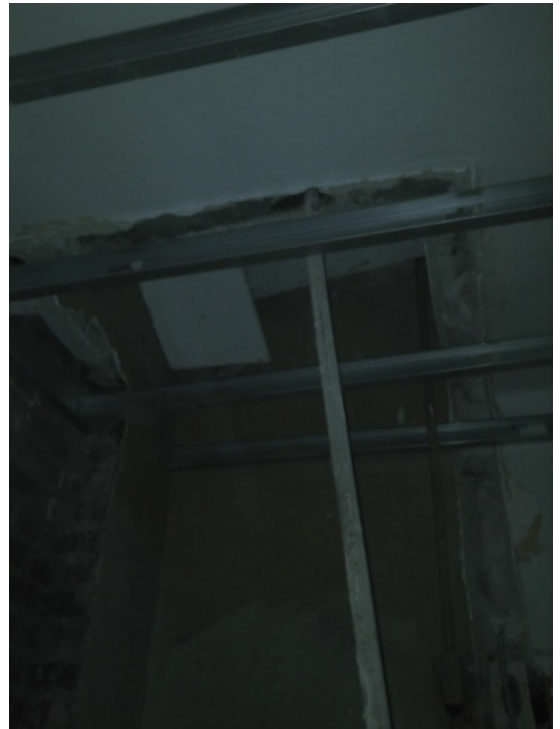
Photo 2 of 5 performance level
 048.jpg
 Date: 14.09.2011
 8F proposed trash chute kitchen

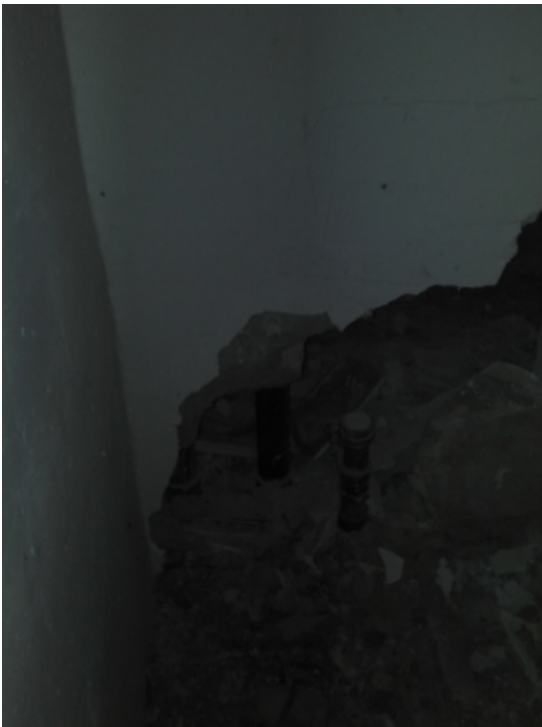
Photo 4 of 5 performance level
 045.jpg
 Date: 14.09.2011
 8F water domestic off chaise in water closet

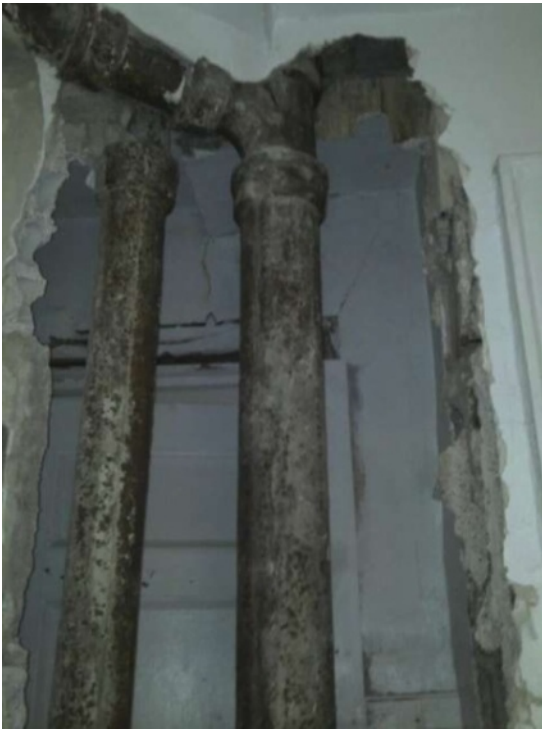
Photo 6 of 5 performance level
035.jpg
Date: 14.09.2011
8F waste line

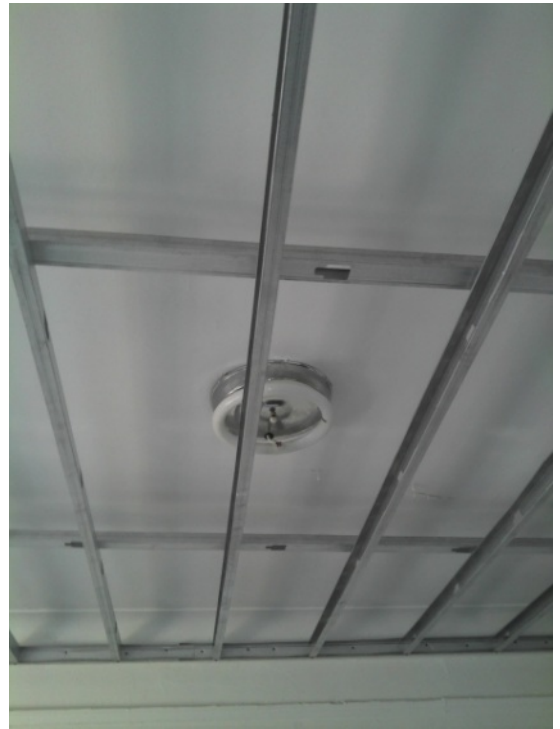
Ceiling Framing
 Based upon my conversation with the Architect (Ray Warner), and a review of the plans the contractor is using the incorrect application to install the ceiling frame. A wrought iron material is detailed rather than metal framing. In addition the residents are desirous of keeping the current ceiling aesthetic, therefore I posed the question to the Architect would it be possible to provide wiring molding form the ceiling light to the wall. He advised me that in his opinion the living room and traditional dining room should not have dropped ceilings.

Photo 1 of 3 inadequacies
042.jpg
Date: 14.09.2011
Ceiling frame 8F bedroom

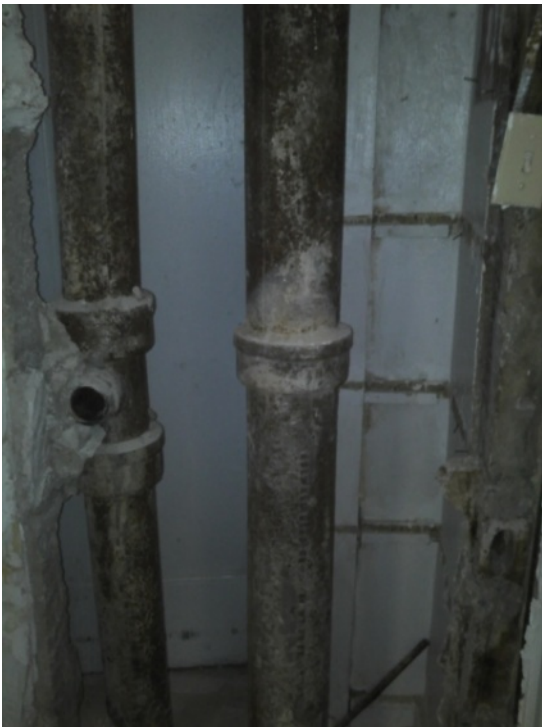
Inadequacies (general): (see photos) Galvanized Pipes
 In consideration of the pipe material (galvanized steel), the age of the building and the life expectance of galvanized pipe it is my opinion that the piping needs to be replaced. It appears that the pipes were from the original construction dating back ninety-five (95) years to approximately 1914. Galvanized pipes generally have a life expectance of fifth (50) years. Therefore the life expectance of the pipes has been surpassed by approximately forty-seven (47) years. Although the City of New York primarily has soft water over ninety-five years the mineral build up from water and waste will significantly affect any pipe material. In unit 2F a pipe was cut open which exposed severe mineral build-up indicative of the stoppage in that pipe, on the second level, but did not manifest at the lower level (basement). Unfortunately, two things general happen to galvanized pipes of this age. One, the aforementioned mineral build-up and two the severe corrosion at the joints. When the pipes are threaded the protective galvanize is cut away, thus exposing bare metal. Over time the joints will corrode and eventually break. Even the partial replacement of the pipes will undermine the joints thus creating the expeditious break in joints.

Photo 2 of 3 inadequacies
037.jpg
Date: 14.09.2011
Galvanized Pipe bathroom 10F

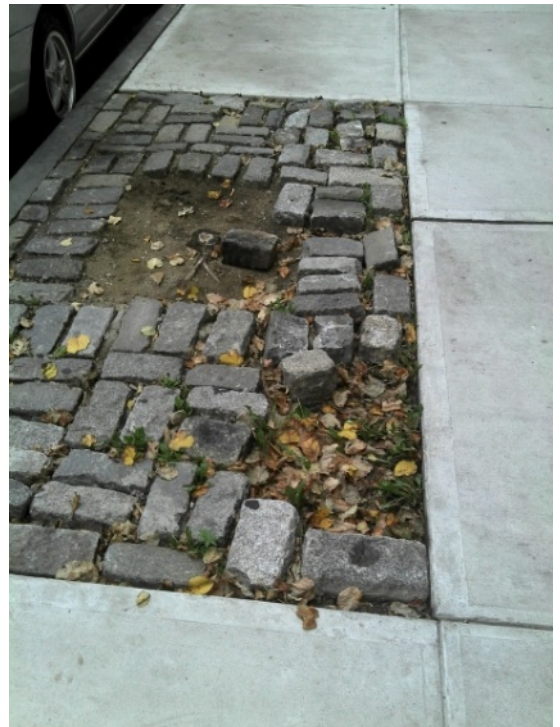
It appears the cobblestones to prop open the doors come from the tree wells in the front of the building. The cobblestones are loose and need to be properly affixed to reduce the current "trip" hazzard.

Photo 3 of 3 inadequacies
050.jpg
Date: 14.09.2011
Tree well cobblestones
